DEPARTMENT OF TRANSPORTATION

Quality Assurance and Source Inspection

Contract #: 04-0120F4Cty: SF/ALA Rte: 80 PM: 13.2/13.9File #: 69.15**SOURCE INSPECTION REPORT****Resident Engineer:** Pursell, Gary**Address:** 333 Burma Road**City:** Oakland, CA 94607**Report No:** SIR-000598**Date Inspected:** 08-May-2009**Project Name:** SAS Superstructure**OSM Arrival Time:** 0**Prime Contractor:** American Bridge/Fluor Enterprises, a JV**OSM Departure Time:** 12**Contractor:** Zhenhua Port Machinery Company, Ltd (ZPMC), Changxing Island**Location:** Changxing Dao, Shanghai

Other: Surface Preparation and Coatings Application**Bridge No:** 34-0006**Component:** OBG, Misc. Metal**Bid Item:** 77,78,79,80**Lot No:** B226**Summary of Items Observed:**

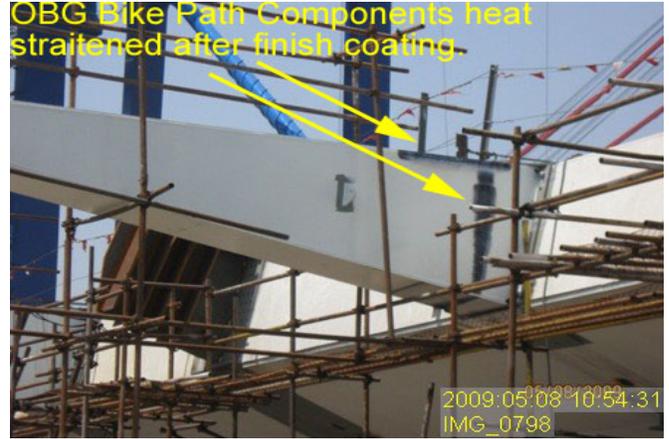
Caltrans QA Coatings Inspector Jordan performed a cursory review of OBG bike path components stored in the OBG trial assembly area. The interior portions of the bike path components have not been coated according to contract requirements. Mr. Oak was informed. Mr. Oak stated that they had an RFI out to address this issue.
