DEPARTMENT OF TRANSPORTATION

Contract #: 04-0120F4Cty: SF/ALA Rte: 80 PM: 13.2/13.9File #: 69.15**SOURCE INSPECTION REPORT****Resident Engineer:** Pursell, Gary**Address:** 333 Burma Road**City:** Oakland, CA 94607**Report No:** SIR-000601**Date Inspected:** 28-Apr-2009**Project Name:** SAS Superstructure**OSM Arrival Time:** 0**Prime Contractor:** American Bridge/Fluor Enterprises, a JV**OSM Departure Time:** 12**Contractor:** Zhenhua Port Machinery Company, Ltd (ZPMC), Changxing Island**Location:** Changxing Dao, Shanghai

Other: Surface Preparation and Coatings Application**Bridge No:** 34-0006**Component:** OBG 6BW, 6AW, 5BE, 1BW**Bid Item:** 79, 80, 81**Lot No:** B226**Summary of Items Observed:**

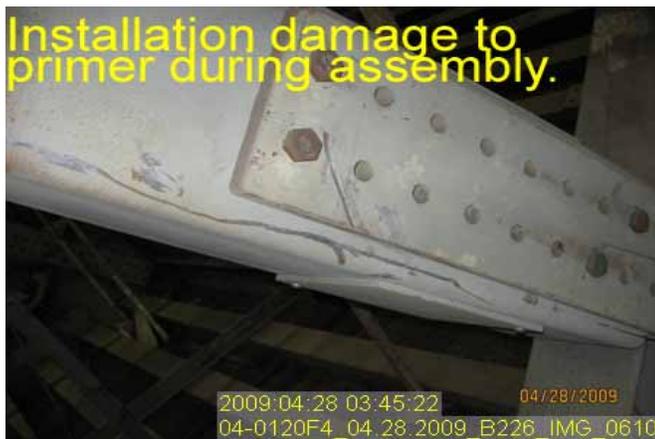
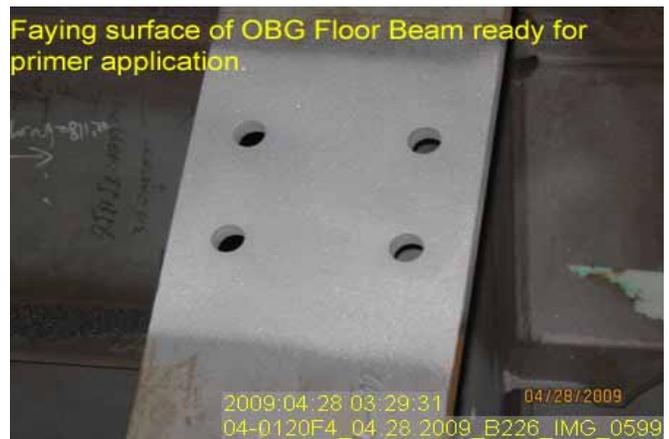
Fabrication on assembled components of the OBG's are not complete. Coating damage requiring re-blast is expected.
