DEPARTMENT OF TRANSPORTATION

DIVISION OF ENGINEERING SERVICES

Contract #: 04-0120F4Cty: SF/ALA Rte: 80 PM: 13.2/13.9File #: 69.15**SOURCE INSPECTION REPORT****Resident Engineer:** Pursell, Gary**Address:** 333 Burma Road**City:** Oakland, CA 94607**Report No:** SIR-000602**Date Inspected:** 01-May-2009**Project Name:** SAS Superstructure**OSM Arrival Time:** 0**Prime Contractor:** American Bridge/Fluor Enterprises, a JV**OSM Departure Time:** 12**Contractor:** Zhenhua Port Machinery Company, Ltd (ZPMC), Changxing Island **Location:** Changxing Dao, Shanghai

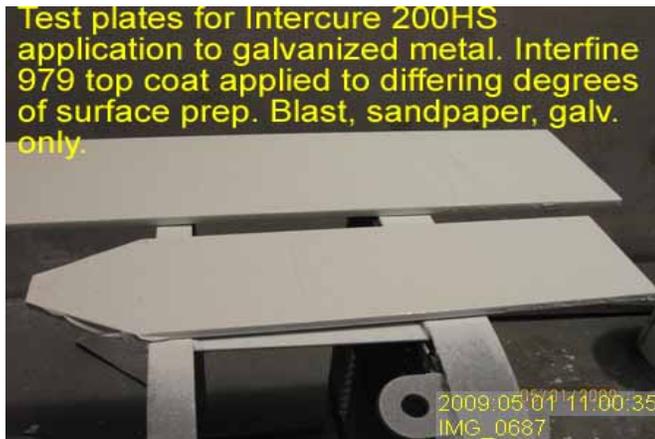
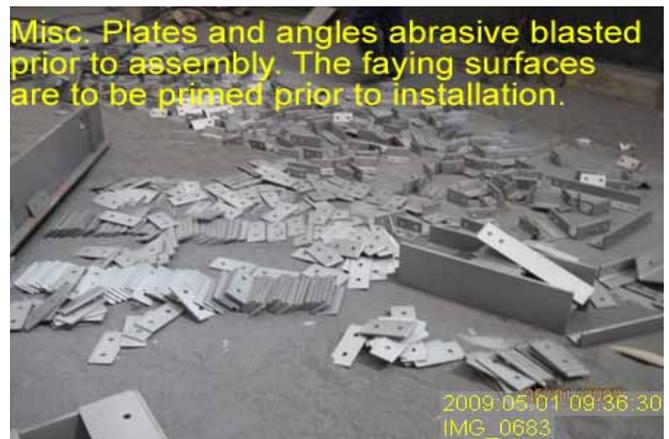
Fabrication on assembled components of the OBG's are not complete. Coating damage requiring re-blast is expected.
