DEPARTMENT OF TRANSPORTATION

Contract #: 04-0120F4Cty: SF/ALA Rte: 80 PM: 13.2/13.9File #: 69.15**SOURCE INSPECTION REPORT****Resident Engineer:** Pursell, Gary**Address:** 333 Burma Road**City:** Oakland, CA 94607**Report No:** SIR-000605**Date Inspected:** 09-May-2009**Project Name:** SAS Superstructure**OSM Arrival Time:** 0**Prime Contractor:** American Bridge/Fluor Enterprises, a JV**OSM Departure Time:** 12**Contractor:** Zhenhua Port Machinery Company, Ltd (ZPMC), Changxing Island**Location:** Changxing Dao, Shanghai

Other: Surface Preparation and Coatings Application**Bridge No:** 34-0006**Component:** OBG 5AW, Misc. Metal**Bid Item:** 77,78,79,80**Lot No:** B226**Summary of Items Observed:**

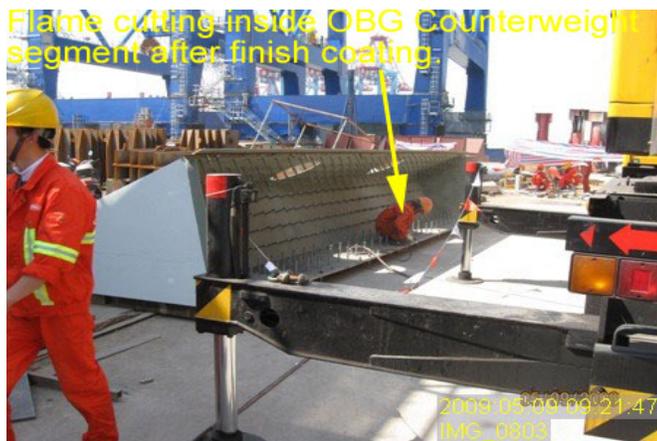
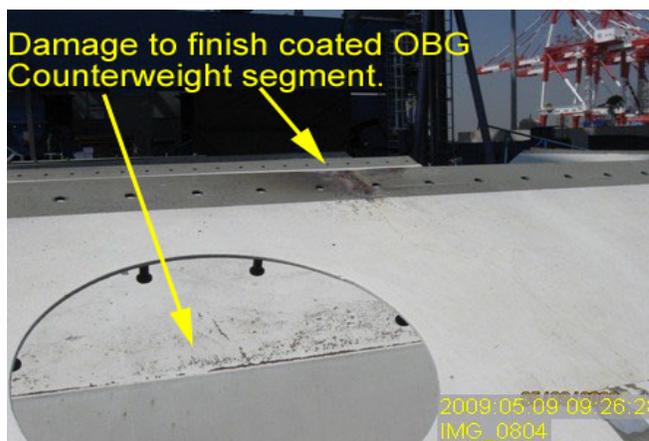
A few spots of grinding were required to remove arc strikes, sharp edges, dings in the substrate that left sharp edges sticking up, and edge conditioning required by the Project Special Provisions Section 10-1.69. After the grinding was completed the surfaces were re-blasted to meet the SSPC SP10 Contract requirements. Surface profile Testex Tape was used by ZPMC QC personnel to record the blast profile. The Testex tape was measured using a dial micrometer. The readings were within the contract requirements of 40 and 86 microns. Ambient conditions were within Contract required parameters. ZPMC was allowed to proceed with applying the Interzinc 22 primer coat. Mixing and application was not witnessed by Caltrans Coatings Inspectors.

Fabrication on assembled components of the OBG's are not complete. Coating damage requiring re-blast is expected.
