DEPARTMENT OF TRANSPORTATION

Quality Assurance and Source Inspection

Contract #: 04-0120F4Cty: SF/ALA Rte: 80 PM: 13.2/13.9File #: 69.15**SOURCE INSPECTION REPORT****Resident Engineer:** Pursell, Gary**Address:** 333 Burma Road**City:** Oakland, CA 94607**Report No:** SIR-000632**Date Inspected:** 23-May-2009**Project Name:** SAS Superstructure**OSM Arrival Time:** 0**Prime Contractor:** American Bridge/Fluor Enterprises, a JV**OSM Departure Time:** 12**Contractor:** Zhenhua Port Machinery Company, Ltd (ZPMC), Changxing Island **Location:** Changxing Dao, Shanghai

Other: Surface Preparation and Coatings Application**Bridge No:** 34-0006**Component:** OBG 1AAE Lift 1,2,3 CB4, Tower L1E**Bid Item:** 77,78,79,80**Lot No:** B226**Summary of Items Observed:**

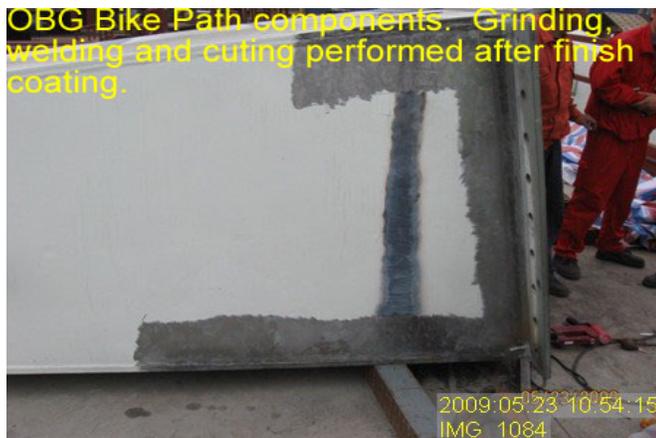
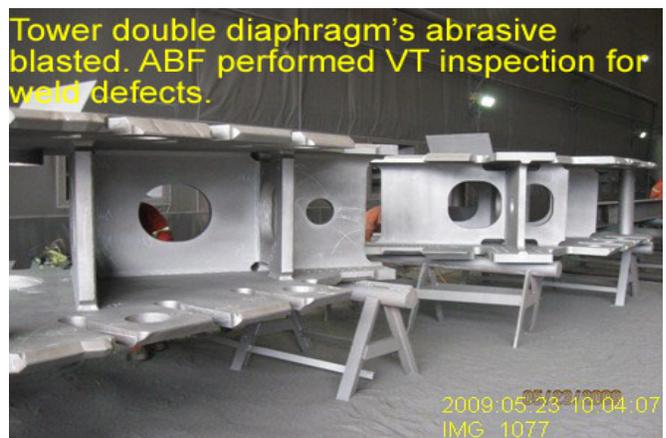
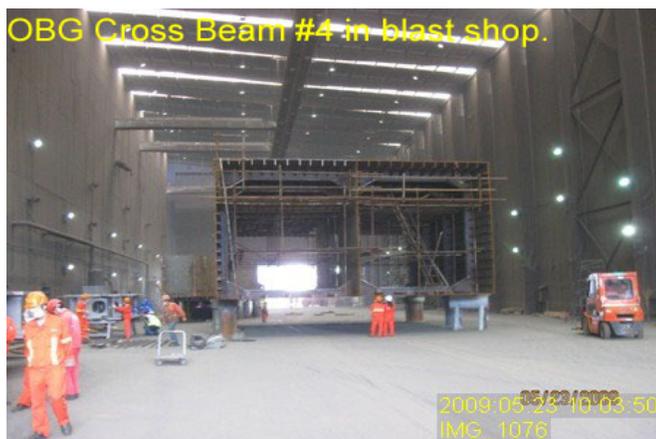
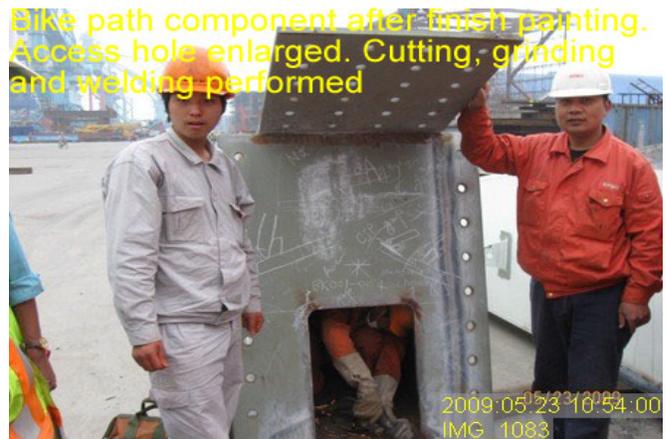
Caltrans QA Coatings Inspectors received a Notice of Inspection for to attend a joint inspection with ABF and ZPMC QC to look at the abrasive blasted surfaces of the OBG counterweight areas on lifts 1, 2, and 3. The surfaces were not ready for inspection. Old weld spots, arc strikes, and spots where steel was cut away from the base metal required grinding before the area could be acceptable for coating application. Grinding was performed. Abrasive blasting of the areas began prior to the end of Caltrans QA Coating Inspector Jordan's shift. Surface preparation inspection will be performed by Caltrans QA Coating Inspector James Lumley.

Fabrication on assembled components of the OBG's and Towers are not complete. Outstanding weld repairs have not been performed. Coating damage requiring re-blast is expected.
