DEPARTMENT OF TRANSPORTATION

Contract #: 04-0120F4Cty: SF/ALA Rte: 80 PM: 13.2/13.9File #: 69.15**SOURCE INSPECTION REPORT****Resident Engineer:** Pursell, Gary**Address:** 333 Burma Road**City:** Oakland, CA 94607**Report No:** SIR-000655**Date Inspected:** 31-May-2009**Project Name:** SAS Superstructure**OSM Arrival Time:** 0**Prime Contractor:** American Bridge/Fluor Enterprises, a JV**OSM Departure Time:** 12**Contractor:** Zhenhua Port Machinery Company, Ltd (ZPMC), Changxing Island**Location:** Changxing Dao, Shanghai

Other: Surface Preparation and Coatings Application**Bridge No:** 34-0006**Component:** OBG L3,L4, Tower L1E**Bid Item:** 77,78,79,80**Lot No:** B226**Summary of Items Observed:**

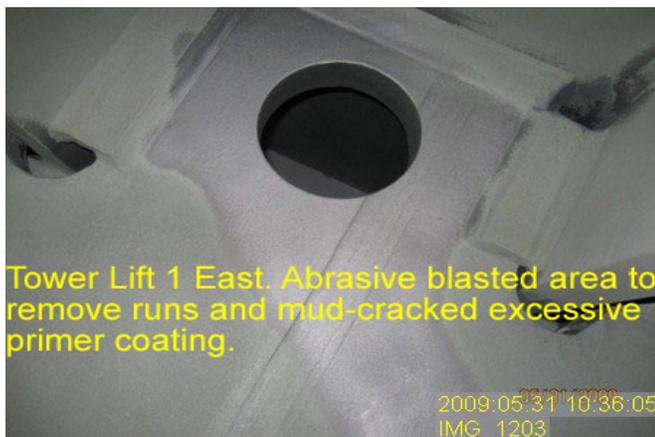
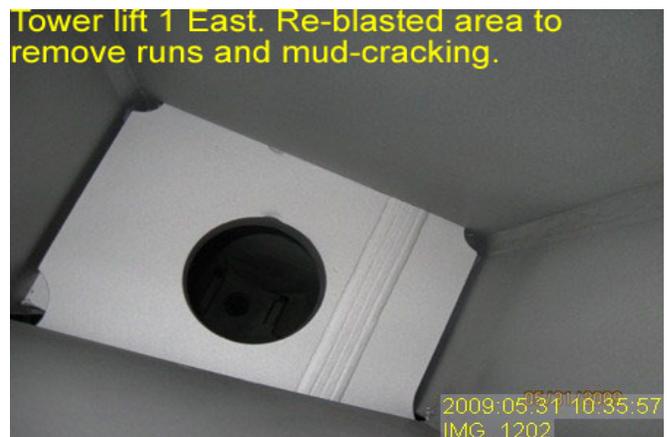
Fabrication on assembled components of the OBG's and Towers are not complete. Outstanding weld repairs have not been performed. Coating damage requiring re-blast is expected.
