DEPARTMENT OF TRANSPORTATION

Contract #: 04-0120F4Cty: SF/ALA Rte: 80 PM: 13.2/13.9File #: 69.15**SOURCE INSPECTION REPORT****Resident Engineer:** Pursell, Gary**Address:** 333 Burma Road**City:** Oakland, CA 94607**Report No:** SIR-000659**Date Inspected:** 06-Jun-2009**Project Name:** SAS Superstructure**OSM Arrival Time:** 0**Prime Contractor:** American Bridge/Fluor Enterprises, a JV**OSM Departure Time:** 12**Contractor:** Zhenhua Port Machinery Company, Ltd (ZPMC), Changxing Island**Location:** Changxing Dao, Shanghai

Other: Surface Preparation and Coatings Application**Bridge No:** 34-0006**Component:** OBG 1AA, 5CE, L3,L4,L5**Bid Item:** 77,78,79,80**Lot No:** B226**Summary of Items Observed:**

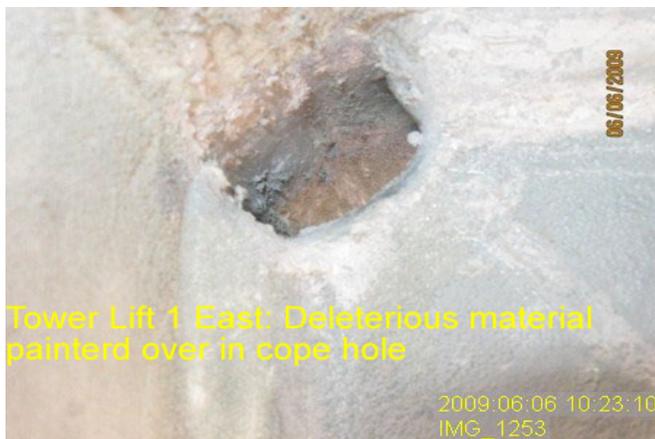
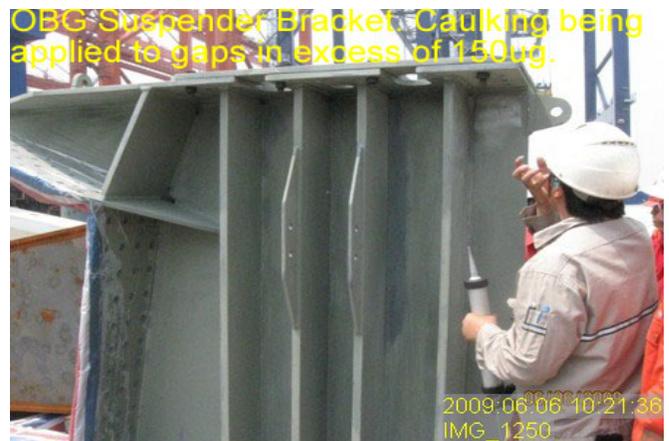
Fabrication on assembled components of the OBG's and Towers are not complete. Outstanding weld repairs have not been performed. Coating damage requiring re-blast is expected.
