Contract #: 04-0120F4Cty: SF/ALA Rte: 80 PM: 13.2/13.9File #: 69.15**SOURCE INSPECTION REPORT****Resident Engineer:** Pursell, Gary**Address:** 333 Burma Road**City:** Oakland, CA 94607**Report No:** SIR-000671**Date Inspected:** 07-Jun-2009**Project Name:** SAS Superstructure**OSM Arrival Time:** 0**Prime Contractor:** American Bridge/Fluor Enterprises, a JV**OSM Departure Time:** 12**Contractor:** Zhenhua Port Machinery Company, Ltd (ZPMC), Changxing Island**Location:** Changxing Dao, Shanghai

**OBG Trial Assembly**

# SOURCE INSPECTION REPORT

## OBG Lift 4W

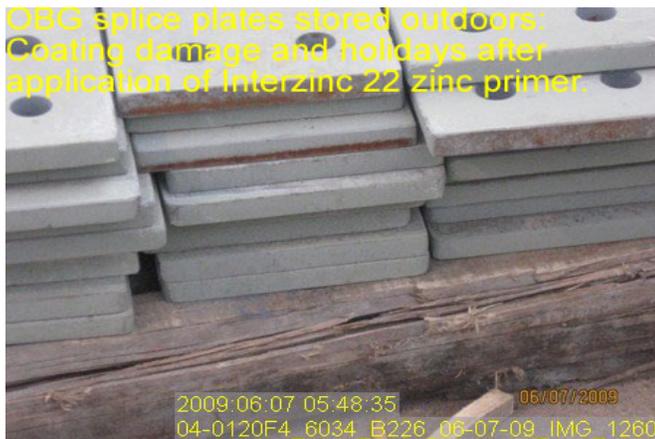
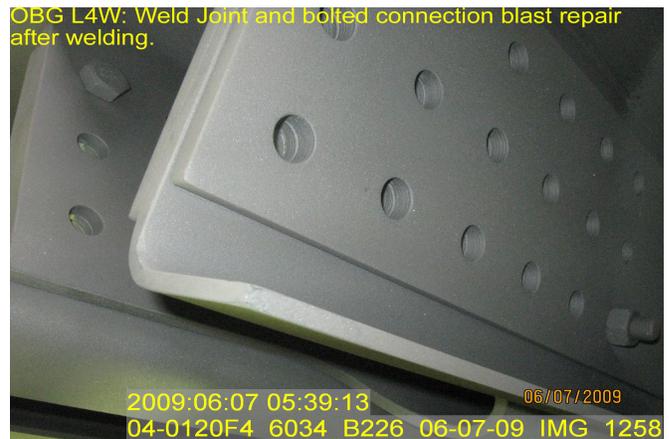
Caltrans QA Coatings Inspectors received a Notice of Inspection to attend a joint inspection with ABF and ZPMC QC for surface preparation by abrasive blasting. The inspection consisted of looking at the abrasive blasted repair areas of OBG Lift 4W.

After looking at the abrasive blasted surfaces it was determined by ABF that the base metal did not meet the SSPC SP10 Near White Metal Contract requirements. ZPMC was informed that further grinding and abrasive blasting was required.

Fabrication on assembled components of the OBG's and Towers are not complete. Outstanding weld repairs have not been performed. Coating damage requiring re-blast is expected.
