**DEPARTMENT OF TRANSPORTATION**

Contract #: 04-0120F4Cty: SF/ALA Rte: 80 PM: 13.2/13.9File #: 69.15**SOURCE INSPECTION REPORT****Resident Engineer:** Pursell, Gary**Address:** 333 Burma Road**City:** Oakland, CA 94607**Report No:** SIR-000674**Date Inspected:** 12-Jun-2009**Project Name:** SAS Superstructure**OSM Arrival Time:** 0**Prime Contractor:** American Bridge/Fluor Enterprises, a JV**OSM Departure Time:** 12**Contractor:** Zhenhua Port Machinery Company, Ltd (ZPMC), Changxing Island **Location:** Changxing Dao, Shanghai

**Other:** Surface Preparation and Coatings Application**Bridge No:** 34-0006**Component:** OBG Lift 4, Tower L4S**Bid Item:** 77,78,79,80**Lot No:** B226**Summary of Items Observed:**

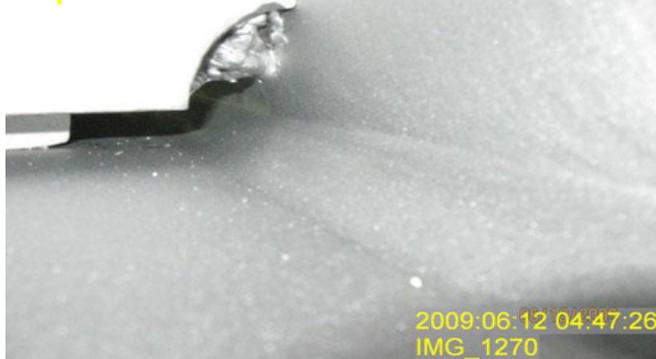
Tower Lift 1 South: Weld inside cope hole

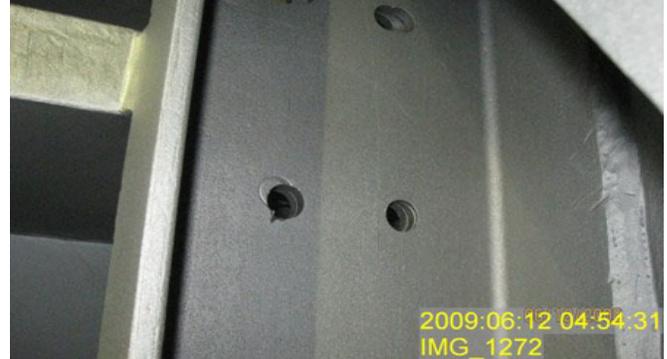
Tower Lift 1 South: Mis aligned bolt holes
