**DEPARTMENT OF TRANSPORTATION**

Office of Structural Materials

Contract #: 04-0120F4Cty: SF/ALA Rte: 80 PM: 13.2/13.9File #: 69.15**SOURCE INSPECTION REPORT****Resident Engineer:** Pursell, Gary**Address:** 333 Burma Road**City:** Oakland, CA 94607**Report No:** SIR-000676**Date Inspected:** 10-Jun-2009**Project Name:** SAS Superstructure**OSM Arrival Time:** 0**Prime Contractor:** American Bridge/Fluor Enterprises, a JV**OSM Departure Time:** 12**Contractor:** Zhenhua Port Machinery Company, Ltd (ZPMC), Changxing Island**Location:** Changxing Dao, Shanghai

**Other:** Surface Preparation and Coatings Application**Bridge No:** 34-0006**Component:** OBG Lift Frames, OBG Trial Assembly, Tower**Bid Item:** 77,78,79,80**Lot No:** B226**Summary of Items Observed:**

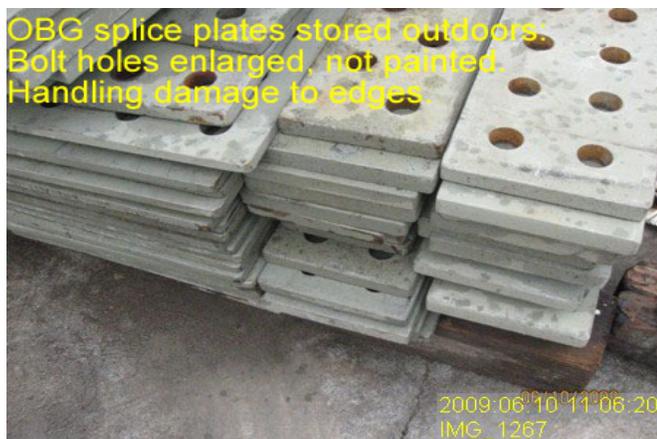
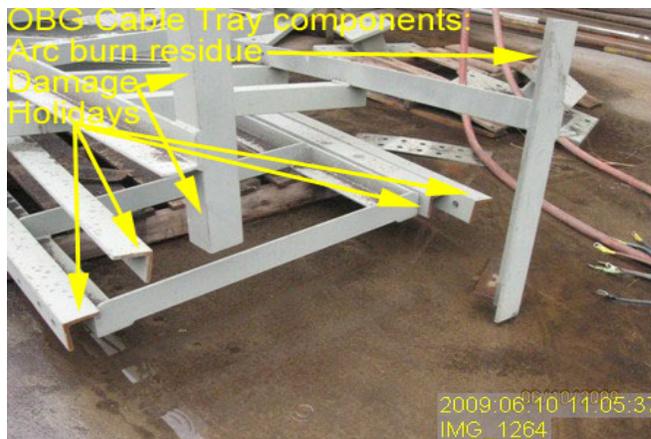
Photos attached are of splice plates and cable tray components stored in the OBG Trial Assembly area in need of repair.

Fabrication on assembled components of the OBG's and Towers are not complete. Outstanding weld repairs have not been performed. Coating damage requiring re-blast is expected.
