DEPARTMENT OF TRANSPORTATION

Contract #: 04-0120F4Cty: SF/ALA Rte: 80 PM: 13.2/13.9File #: 69.15**SOURCE INSPECTION REPORT****Resident Engineer:** Pursell, Gary**Address:** 333 Burma Road**City:** Oakland, CA 94607**Report No:** SIR-000690**Date Inspected:** 20-Jun-2009**Project Name:** SAS Superstructure**OSM Arrival Time:** 0**Prime Contractor:** American Bridge/Fluor Enterprises, a JV**OSM Departure Time:** 12**Contractor:** Zhenhua Port Machinery Company, Ltd (ZPMC), Changxing Island**Location:** Changxing Dao, Shanghai

Other: Surface Preparation and Coatings Application**Bridge No:** 34-0006**Component:** Tower L1S, Samples**Bid Item:** 77,78,79,80**Lot No:** B226**Summary of Items Observed:**

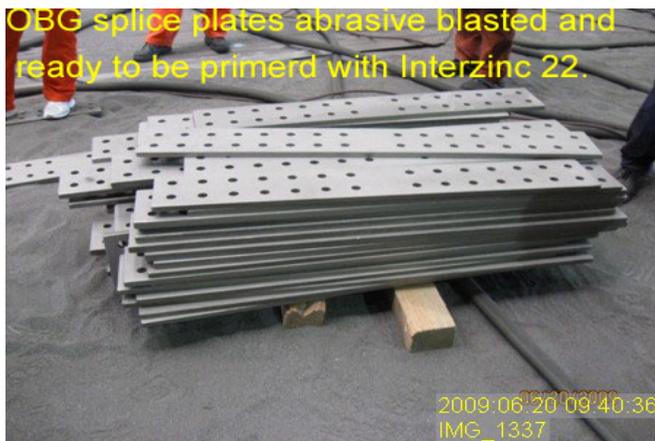
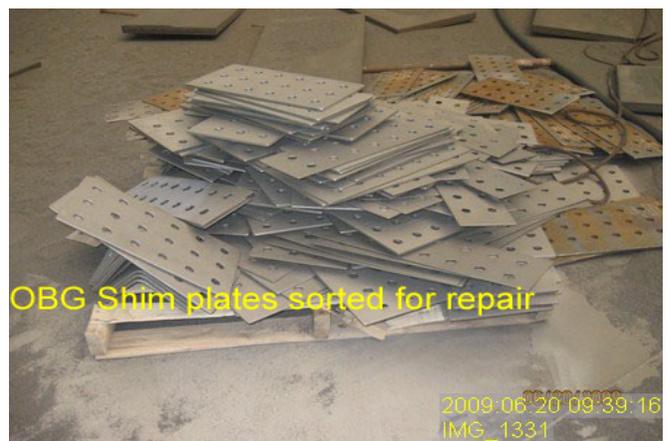
Fabrication on assembled components of the OBG's and Towers are not complete. Outstanding weld repairs have not been performed. Coating damage requiring re-blast is expected.
