Contract #: 04-0120F4Cty: SF/ALA Rte: 80 PM: 13.2/13.9File #: 69.15**SOURCE INSPECTION REPORT****Resident Engineer:** Pursell, Gary**Address:** 333 Burma Road**City:** Oakland, CA 94607**Report No:** SIR-000731**Date Inspected:** 23-Jun-2009**Project Name:** SAS Superstructure**OSM Arrival Time:** 0**Prime Contractor:** American Bridge/Fluor Enterprises, a JV**OSM Departure Time:** 12**Contractor:** Zhenhua Port Machinery Company, Ltd (ZPMC), Changxing Island**Location:** Changxing Dao, Shanghai

Other: Surface Preparation and Coatings Application**Bridge No:** 34-0006**Component:** OBG L2E, 8AE, 8BE, Tower L1S, L2S**Bid Item:** 77,78,79,80**Lot No:** B226**Summary of Items Observed:**

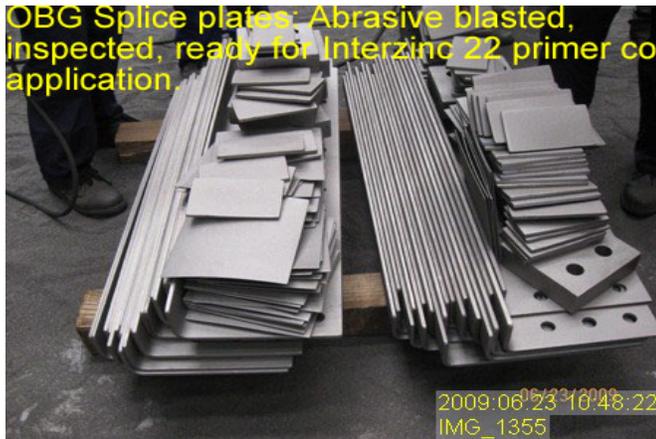
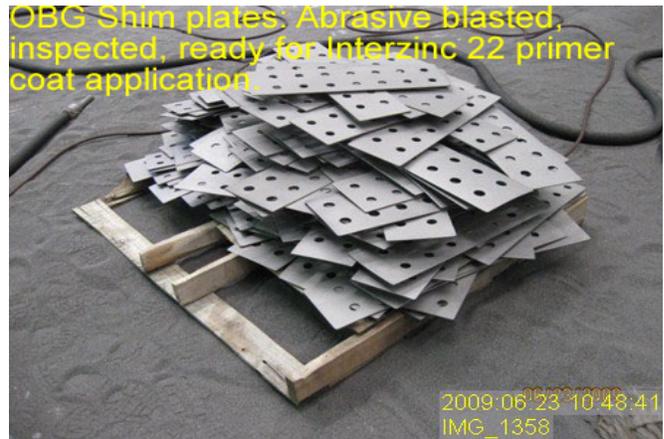
Fabrication on assembled components of the OBG's and Towers are not complete. Outstanding weld repairs have not been performed. Coating damage requiring re-blast is expected.
