Contract #: 04-0120F4Cty: SF/ALA Rte: 80 PM: 13.2/13.9File #: 69.15**SOURCE INSPECTION REPORT****Resident Engineer:** Pursell, Gary**Address:** 333 Burma Road**City:** Oakland, CA 94607**Report No:** SIR-000732**Date Inspected:** 24-Jun-2009**Project Name:** SAS Superstructure**OSM Arrival Time:** 0**Prime Contractor:** American Bridge/Fluor Enterprises, a JV**OSM Departure Time:** 12**Contractor:** Zhenhua Port Machinery Company, Ltd (ZPMC), Changxing Island**Location:** Changxing Dao, Shanghai

Other: Surface Preparation and Coatings Application**Bridge No:** 34-0006**Component:** OBG Misc. Metal, Tower L2S, L2E**Bid Item:** 77,78,79,80**Lot No:** B226**Summary of Items Observed:**

OBG Lift 2 East

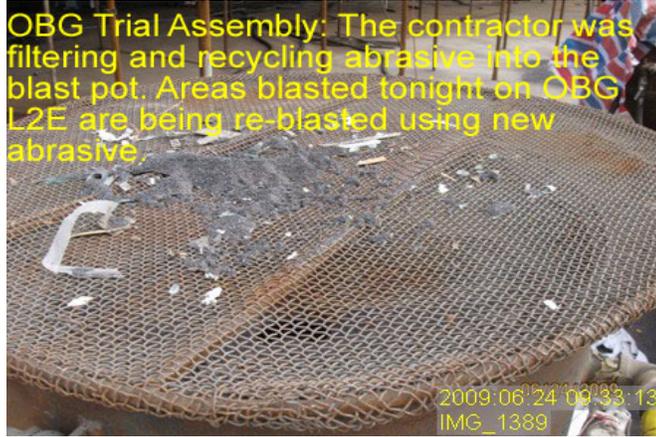
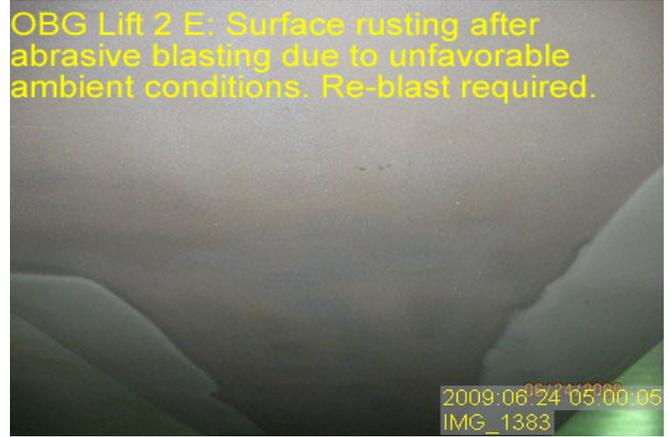
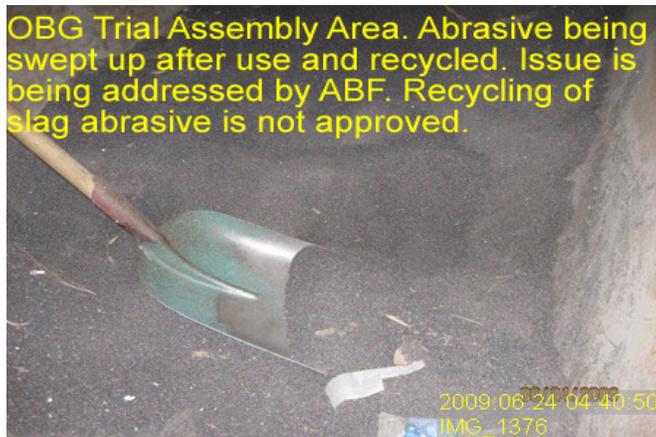
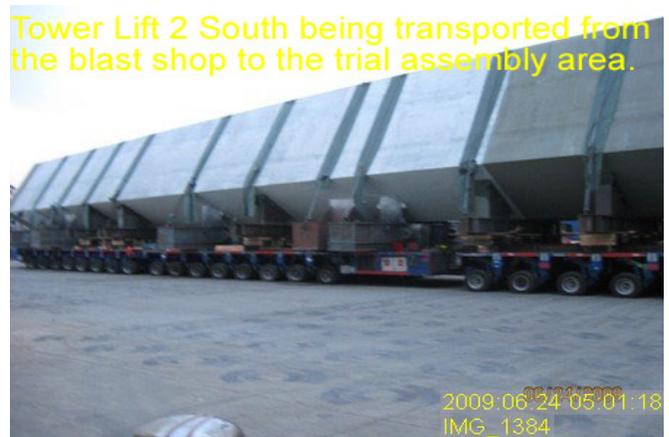
After looking at the abrasive blasted surfaces it was determined by Caltrans QA Coatings Inspector Jordan that the base metal did not meet the Society for Protective Coatings (SSPC) SP10 Near White Metal Contract requirements.

Several areas were beginning to flash rust due to high humidity in the area of the exposed surfaces. Caltrans QA Coatings Inspector Jordan observed ZPMC personnel shoveling abrasive from a dump hopper into the blast pot. Upon investigation the abrasive being used for blasting was filled with foreign materials such as metal shaving, paper and other trash. After inquiring Mr. Jordan was told that this was new abrasive. With further inquiry assisted by ABF QC personnel to assist in communication ZPMC personnel were informed that only new abrasive was approved for blasting on this project. The blast pots were cleaned out and new abrasive used to begin the re-blast.

Several areas were beginning to flash rust due to high humidity in the area of the exposed surfaces. During the inspection it began to rain. Blasting was suspended until the weather improves.
