DEPARTMENT OF TRANSPORTATION

Contract #: 04-0120F4Cty: SF/ALA Rte: 80 PM: 13.2/13.9File #: 69.15**SOURCE INSPECTION REPORT****Resident Engineer:** Pursell, Gary**Address:** 333 Burma Road**City:** Oakland, CA 94607**Report No:** SIR-000733**Date Inspected:** 04-Jul-2009**Project Name:** SAS Superstructure**OSM Arrival Time:** 0**Prime Contractor:** American Bridge/Fluor Enterprises, a JV**OSM Departure Time:** 12**Contractor:** Zhenhua Port Machinery Company, Ltd (ZPMC), Changxing Island **Location:** Changxing Dao, Shanghai

Other: Surface Preparation and Coatings Application**Bridge No:** 34-0006**Component:** OBG L3E, L4E, L5E, Misc. Metal**Bid Item:** 77,78,79,80**Lot No:** B226**Summary of Items Observed:**

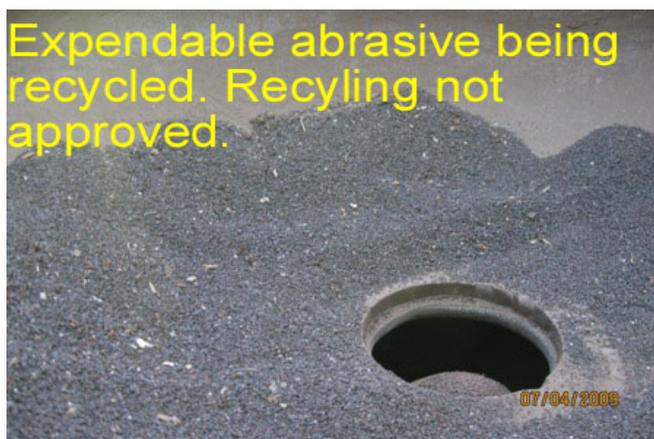
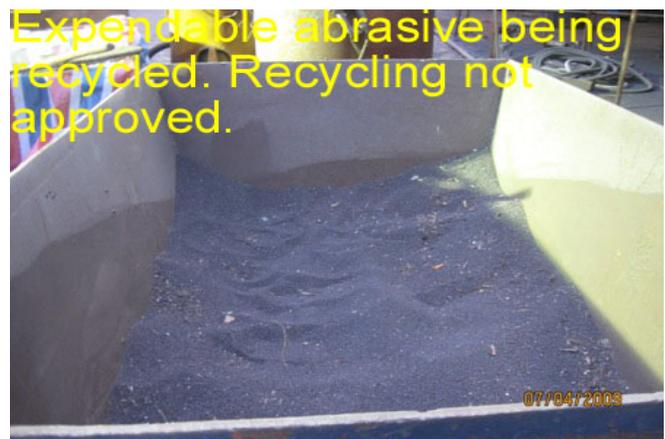
5E weld seam joints. Upon arriving Caltrans QA Coatings Inspector Jordan noticed that ZPMC was recycling the expendable abrasive. This was brought to ABF and ZPMC QC's attention. The blast pots were cleaned out and new abrasive used to re-blast the surfaces with. Additionally the abrasive blasted surfaces did not meet the Society for Protective Coatings (SSPC) SP10 Near White Metal Contract requirements. ZPMC was informed by ABF QC that further grinding and abrasive blasting was required. ABF QC's determination was verified by Caltrans QA Coatings Inspector Jordan. The contractor began performing the repairs as directed by ABF QC personnel.

Upon arriving Caltrans QA Coatings Inspector Jordan noticed that ZPMC was recycling the expendable abrasive. ABF was informed that if the abrasive was recycled again that an Incident Report would be written. Additionally the abrasive blasted surfaces did not meet the Society for Protective Coatings (SSPC) SP10 Near White Metal Contract requirements. ZPMC was informed by ABF QC that further grinding and abrasive blasting was required. ABF QC's determination was verified by Caltrans QA Coatings Inspector Jordan. The contractor began performing the repairs as directed by ABF QC personnel. A third inspection request was not received for this area during the morning shift.
