DEPARTMENT OF TRANSPORTATION

Contract #: 04-0120F4Cty: SF/ALA Rte: 80 PM: 13.2/13.9File #: 69.15**SOURCE INSPECTION REPORT****Resident Engineer:** Pursell, Gary**Address:** 333 Burma Road**City:** Oakland, CA 94607**Report No.:** SIR-000739**Date Inspected:** 08-Jul-2009**Project Name:** SAS Superstructure**OSM Arrival Time:** 0**Prime Contractor:** American Bridge/Fluor Enterprises, a JV**OSM Departure Time:** 12**Contractor:** Zhenhua Port Machinery Company, Ltd (ZPMC), Changxing Island **Location:** Changxing Dao, Shanghai

Other: Surface Preparation and Coatings Application**Bridge No.:** 34-0006**Component:** OBG L2E, L2W, L4E, Misc. Metal**Bid Item:** 77,78,79,80**Lot No.:** B226**Summary of Items Observed:**

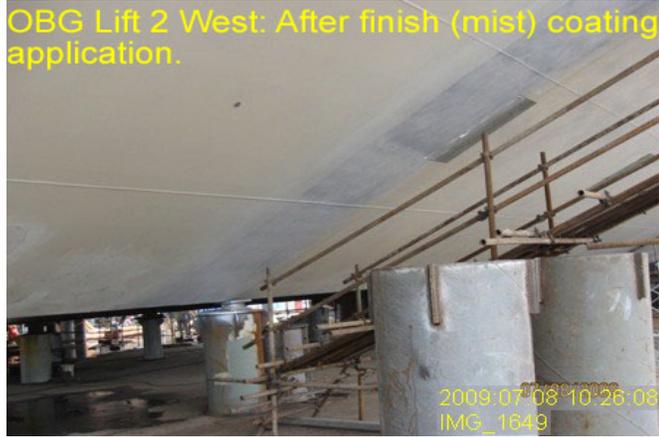
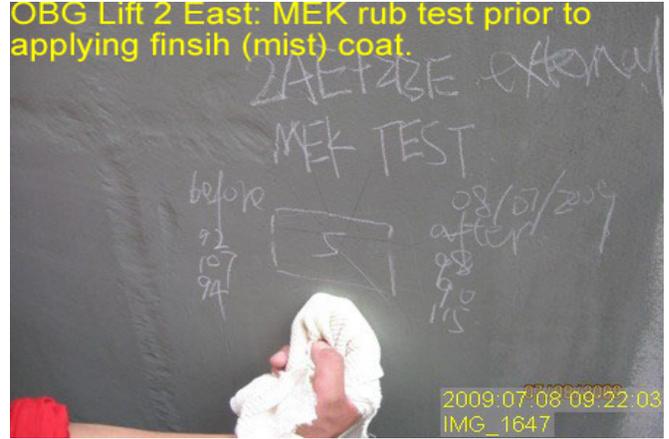
Caltrans QA Coatings Inspectors received a Notice of Inspection to attend a joint inspection with ABF and ZPMC QC for surface preparation inspection prior to finish (mist) coat application on external surfaces of weld seam joints for L2E and L2W. The surfaces were clean and dry. Dry film thicknesses (dft's) readings were within the specified range per contract. The contract required cure tests were performed on the zinc primer and found to be acceptable. The ambient conditions were within the specified ranges of contract requirements for coating application. More feathering along the edges was required prior to finish (mist) coat application. Some sanding of areas that had been burnished during feathering was required.

The contractor was informed that according to State Letter No. 05.03.01-004556, no coating was to be applied outside the approved paint facility. If he chooses to continue an Incident Report would be written. Once these issues were address and corrected the contractor decided to apply the finish (mist) coat. An Incident Report was issued based upon Caltrans State Letter No. 05.03.01-004556 "Provide an MFSQA to the Department should ZPMC wish to proceed with the application of paint outside of the approved facility as was previously noted during the audit performed on November 28, 2008."

It was observed by Caltrans QA Coatings Inspector Jordan that touch up of feathered edges where the coating was removed to bare metal was being performed by applying Interzinc 52.

This application area also falls under the Incident Report issued that is described above.
