**DEPARTMENT OF TRANSPORTATION**

Contract #: 04-0120F4Cty: SF/ALA Rte: 80 PM: 13.2/13.9File #: 69.15**SOURCE INSPECTION REPORT****Resident Engineer:** Pursell, Gary**Address:** 333 Burma Road**City:** Oakland, CA 94607**Report No:** SIR-000742**Date Inspected:** 11-Jul-2009**Project Name:** SAS Superstructure**OSM Arrival Time:** 0**Prime Contractor:** American Bridge/Fluor Enterprises, a JV**OSM Departure Time:** 12**Contractor:** Zhenhua Port Machinery Company, Ltd (ZPMC), Changxing Island **Location:** Changxing Dao, Shanghai

**Other:** Surface Preparation and Coatings Application**Bridge No:** 34-0006**Component:** OBG L4E, Misc. Metal, Tower L1E**Bid Item:** 77,78,79,80**Lot No:** B226**Summary of Items Observed:**

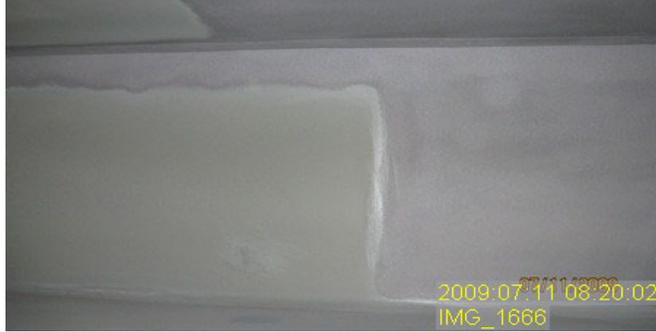
Caltrans QA Coatings Inspectors received Notices of Inspection to attend a joint inspection with ABF and ZPMC QC for degreasing inspection on the internal surfaces of tower lift 1 East. There was no visible oil or grease on the surfaces inspected. It was observed by Mr. Jordan that there were no bags of new abrasive at the blast pots so ABF QC was reminded that recycling of abrasive other than the steel abrasive in the blast shop is not allowed. Again ABF QC personnel were reminded that an Incident Report will be written if any coating was applied because of Caltrans Letter No. 05.03.01-004556 which states "Provide an MFSQA to the Department should ZPMC wish to proceed with the application of paint outside of the approved facility as was previously noted during the audit performed on November 28, 2008."

Tower Lift 1 East: Low dry film thickness repair areas. Re-blast requires. Does not meet contract requirements for cleanliness

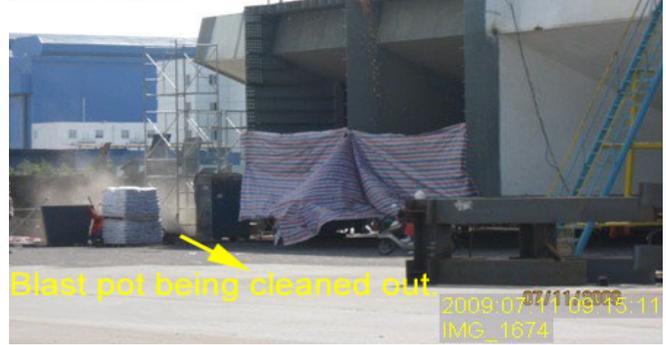
Caltrans QA Coatings Inspectors received Notices of Inspection to attend joint inspections with ABF and ZPMC QC for surface preparation by abrasive blasting and primer coat application on OBG L4E cross beam connection area and support areas located in the OBG trial assembly area. Caltrans QA Coatings Inspector Jordan arrived at the inspection site early. Abrasive blasting was still in progress. Shortly after Mr. Jordan's arrival, half an hour before the inspection time a fork lift arrived with a pallet of new abrasive. The blast hose was disconnected from the blast pot. The blast pot was blown out. At the inspection time the inspection was canceled by ZPMC. They stated the reason for the cancelation was that fabrication was not complete in the work area.

OBG Lift 4 East: Fabrication continues above the area prepared for coating application.
