DEPARTMENT OF TRANSPORTATION

Contract #: 04-0120F4Cty: SF/ALA Rte: 80 PM: 13.2/13.9File #: 69.15**SOURCE INSPECTION REPORT****Resident Engineer:** Pursell, Gary**Address:** 333 Burma Road**City:** Oakland, CA 94607**Report No:** SIR-000743**Date Inspected:** 12-Jul-2009**Project Name:** SAS Superstructure**OSM Arrival Time:** 0**Prime Contractor:** American Bridge/Fluor Enterprises, a JV**OSM Departure Time:** 12**Contractor:** Zhenhua Port Machinery Company, Ltd (ZPMC), Changxing Island**Location:** Changxing Dao, Shanghai

Other: Surface Preparation and Coatings Application**Bridge No:** 34-0006**Component:** OBG CB4, Misc. Metal**Bid Item:** 77,78,79,80**Lot No:** B226**Summary of Items Observed:**

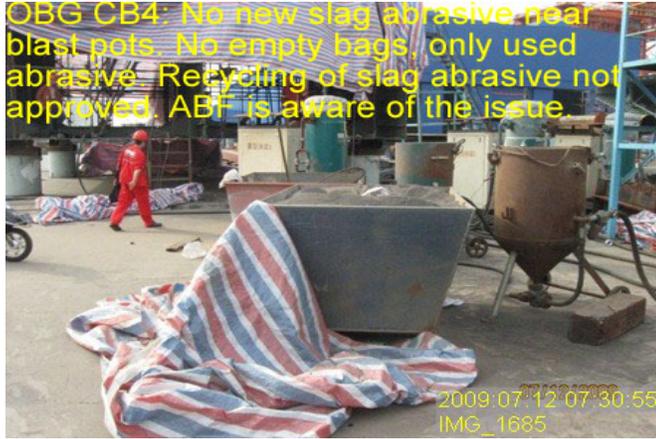
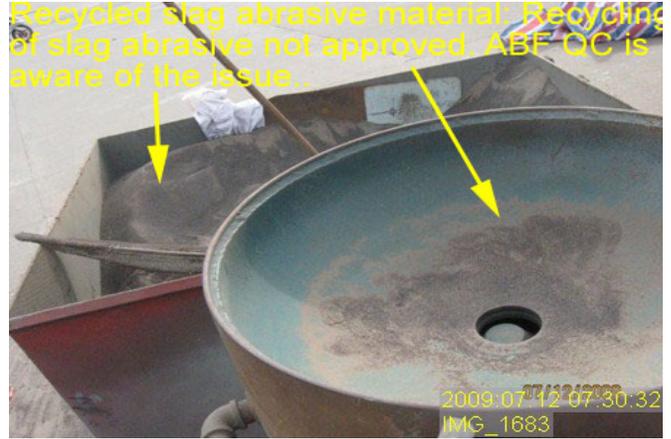
There was no new slag abrasive in the work area of the blast pots. There was dirty abrasive in the blast pot. Caltrans QA Coatings Inspector Jordan pointed this out to ABF) Paint Supervisors William (Bill) Oak. Mr. Oak stated that if new abrasive was not used he would write a Non Conformance Report to ZPMC. Mr. Oak emailed ZPMC QC and management staff regarding the use of recycled Slag abrasive reminding them that it is not allowed per contract. It is unknown what contaminants may be being imbedded into the base metal due to abrasive blasting with used, dirty abrasive.
