DEPARTMENT OF TRANSPORTATION

Contract #: 04-0120F4Cty: SF/ALA Rte: 80 PM: 13.2/13.9File #: 69.15**SOURCE INSPECTION REPORT****Resident Engineer:** Pursell, Gary**Address:** 333 Burma Road**City:** Oakland, CA 94607**Report No:** SIR-000744**Date Inspected:** 15-Jul-2009**Project Name:** SAS Superstructure**OSM Arrival Time:** 0**Prime Contractor:** American Bridge/Fluor Enterprises, a JV**OSM Departure Time:** 12**Contractor:** Zhenhua Port Machinery Company, Ltd (ZPMC), Changxing Island**Location:** Changxing Dao, Shanghai

Other: Surface Preparation and Coatings Application**Bridge No:** 34-0006**Component:** OBG, L4E, 1AAE, Misc. Metal, Tower L1E**Bid Item:** 77,78,79,80**Lot No:** B226**Summary of Items Observed:**

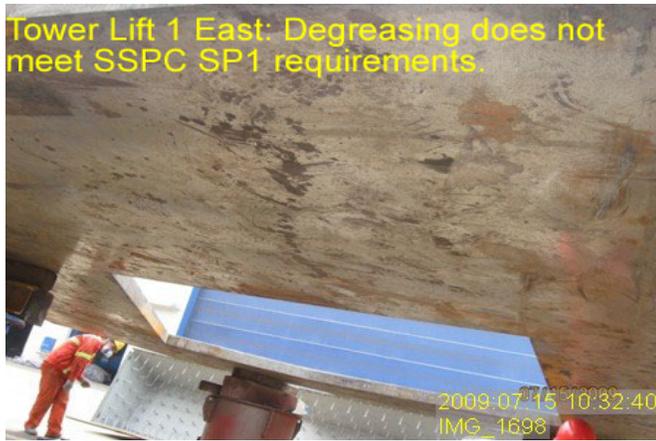
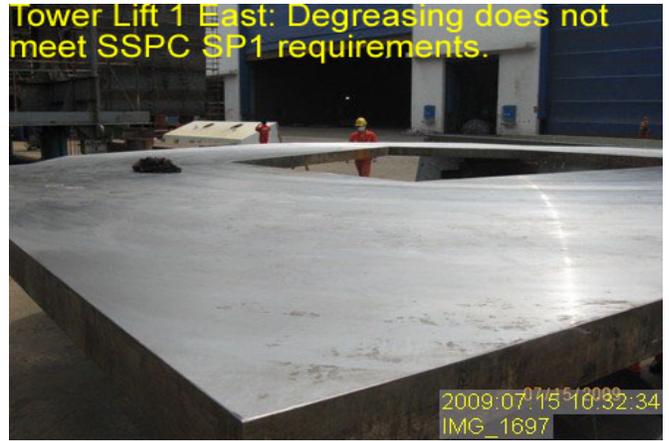
Caltrans QA Coatings Inspectors received a Notice of Inspection to attend a joint inspection with ABF and ZPMC QC for checking the exterior surfaces after degreasing of tower lift 1 East bottom plate. The entire surface was covered in what appeared to be oil or grease that had been spread around. The issue was addressed with ABF QC personnel suggesting that the procedures for cleaning described in the contract documents from The Society for Protective Coatings (SSPC) Surface Preparation method 1. ABF translated the issue to ZPMC. The surface was cleaned again using clean solvent and clean rags. Mr. Jordan pointed out to Mr. Oak that the surface surfaces would require solvent cleaning again prior to abrasive blasting. Several spots of deleterious material remained on the surfaces. Another inspection will be required after the work is complete.

Caltrans QA Coatings Inspectors received a Notice of Inspection to attend a joint inspection with ABF and ZPMC QC for checking the exterior surfaces after degreasing of OBG 1AAE. No effort had been made to clean the surfaces prior to inspection. Mr. Jordan pointed out that the work should be performed prior to calling for inspection. Mr. Jordan observed as workers attempted to remove stains from an unknown contaminate using paint thinner. The dirt was removed but the stains remained. Mr. Jordan suggested that they try water because solvents will not remove some contaminates. Lost in translation the suggestion was not attempted. After half an hour the water and a rag arrived. The stain was removed very easily. The stains were removed prior to spot abrasive blasting on the external surfaces.
