**DEPARTMENT OF TRANSPORTATION**

Office of Structural Materials

Contract #: 04-0120F4Cty: SF/ALA Rte: 80 PM: 13.2/13.9File #: 75.15**SOURCE INSPECTION REPORT****Resident Engineer:** Pursell, Gary**Address:** 333 Burma Road**City:** Oakland, CA 94607**Report No:** SIR-000861**Date Inspected:** 21-Aug-2009**Project Name:** SAS Superstructure**Prime Contractor:** American Bridge/Fluor Enterprises, a JV**Contractor:** Shanghai Pujiang Cable Co. (SPCC)**OSM Arrival Time:** 1000**OSM Departure Time:** 1700**Location:** Bao Steel, Shanghai**Quality Control Contact:** Mr. Pei**Quality Control Present:** Yes No**Material transfer:** Yes No N/A**Sampled Items:** Yes No N/A**Stock Transfer:** Yes No N/A**OK to Cut:** Yes No N/A**Rebar Test Witness:** Yes No N/A**Delayed/Cancelled:** Yes No N/A**Other:** witnessed tensile tests for galvanized wire**Bridge No:** 34-0006**Component:** galvanized wire 5.4mm diameter for cable**Bid Item:** 66A**Lot No:** B240**Summary of Items Observed:**

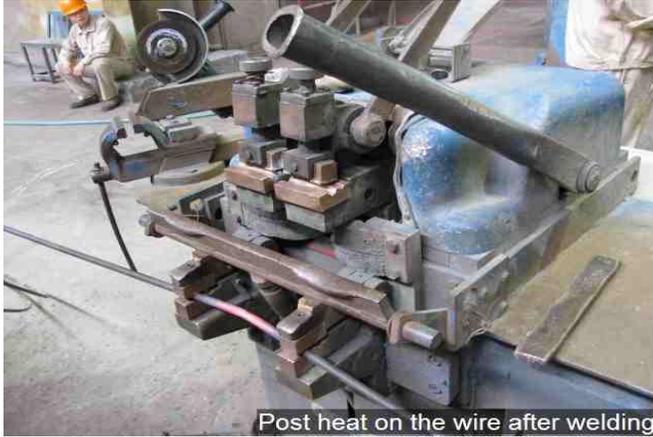
Caltrans QA Inspector Mr. Wai Pau observed two Bao Steel workers in process wire drawing operation. The wire rod size is drawing from 13.0/13.5~11.64~10.29~9.14~8.17~7.35~6.67~6.11~5.66~5.4mm with a drawing speed of 4m/s. During wire drawing, a welding operator performed a friction welding on the both end of wire rod and burnishes the joints. The post heat treating is follow after welding. All the weld joint areas will be remove include the HAZ zone prior the wire is galvanizing. Based on Caltrans QAI observations, no discrepancies were noted.
