DEPARTMENT OF TRANSPORTATION

Quality Assurance and Source Inspection

Contract #: 04-0120F4Cty: SF/ALA Rte: 80 PM: 13.2/13.9File #: 69.15**SOURCE INSPECTION REPORT****Resident Engineer:** Pursell, Gary**Address:** 333 Burma Road**City:** Oakland, CA 94607**Report No:** SIR-000996**Date Inspected:** 09-Oct-2009**Project Name:** SAS Superstructure**OSM Arrival Time:** 645**Prime Contractor:** American Bridge/Fluor Enterprises, a JV**OSM Departure Time:** 1845**Contractor:** Zhenhua Port Machinery Company, Ltd (ZPMC), Changxing Island **Location:** Shanghai, China**Quality Control Contact:****Quality Control Present:** Yes No**Material transfer:** Yes No N/A**Sampled Items:** Yes No N/A**Stock Transfer:** Yes No N/A**OK to Cut:** Yes No N/A**Rebar Test Witness:** Yes No N/A**Delayed/Cancelled:** Yes No N/A**Other:****Bridge No:** 34-0006**Component:** OBG Components**Bid Item:****Lot No:** B 278**Summary of Items Observed:**

Inspection for Surface Preparation and/or Coating Application.

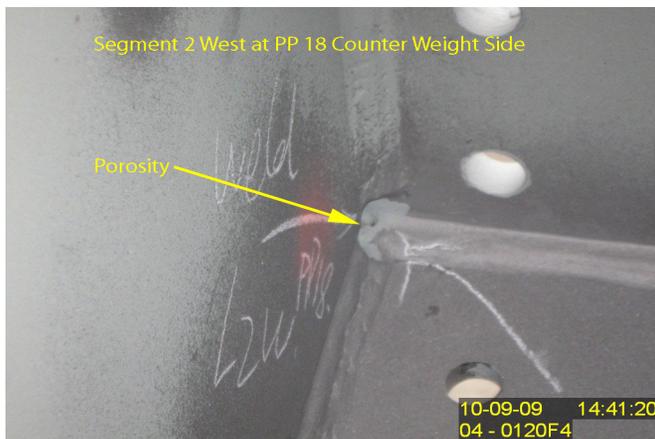
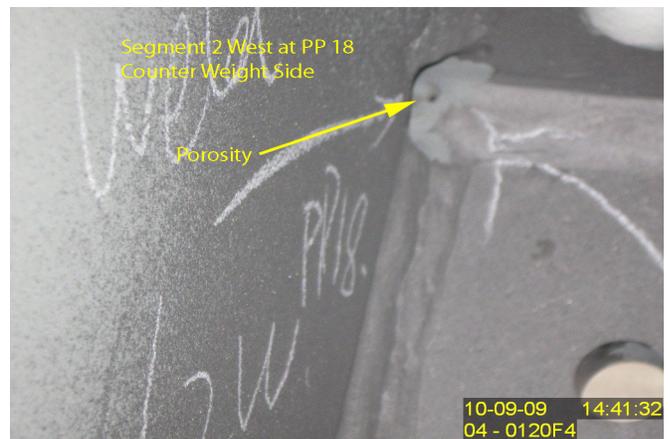
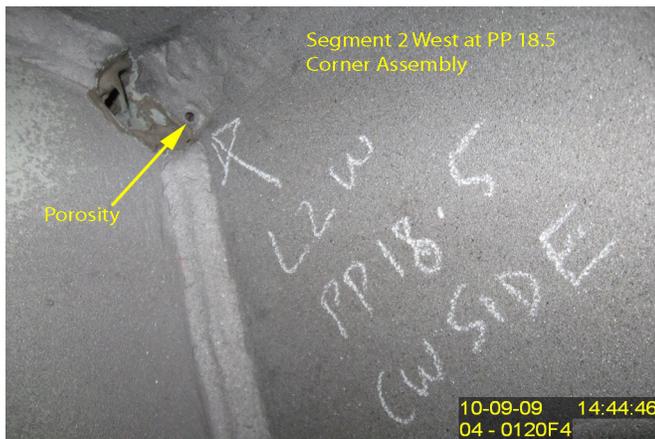
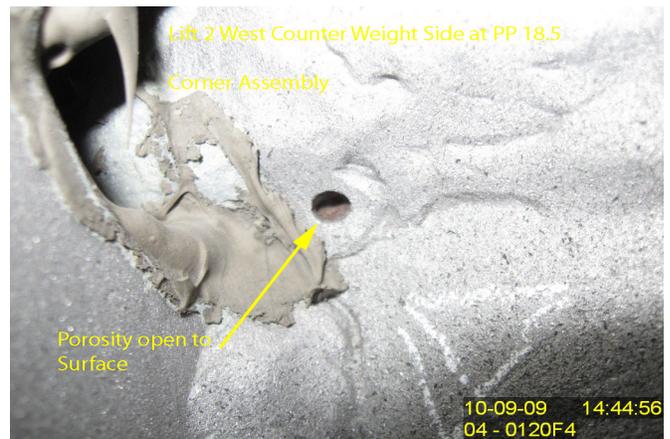
Noticed Porosity open to surface at Corner assembly at PP 18 and at PP 18.5 Counter Weight Side, for more comprehensive details refer the pictures attached.
