DEPARTMENT OF TRANSPORTATION

Quality Assurance and Source Inspection

Contract #: 04-0120F4Cty: SF/ALA Rte: 80 PM: 13.2/13.9File #: 75.15**SOURCE INSPECTION REPORT****Resident Engineer:** Pursell, Gary**Address:** 333 Burma Road**City:** Oakland, CA 94607**Report No:** SIR-001135**Date Inspected:** 23-Oct-2009**Project Name:** SAS Superstructure**OSM Arrival Time:** 730**Prime Contractor:** American Bridge/Fluor Enterprises, a JV**OSM Departure Time:** 1800**Contractor:** Shanghai Pujiang Cable Co. (SPCC)**Location:** Bao Steel, Shanghai**Quality Control Contact:** Mr. Pei**Quality Control Present:** Yes No**Material transfer:** Yes No N/A**Sampled Items:** Yes No N/A**Stock Transfer:** Yes No N/A**OK to Cut:** Yes No N/A**Rebar Test Witness:** Yes No N/A**Delayed/Cancelled:** Yes No N/A**Other:** Witnessed tensile tests for 5.4mm diameter galvanized wire**Bridge No:** 34-0006**Component:** 5.4mm galvanized wire**Bid Item:** 66A**Lot No:** B240**Summary of Items Observed:**

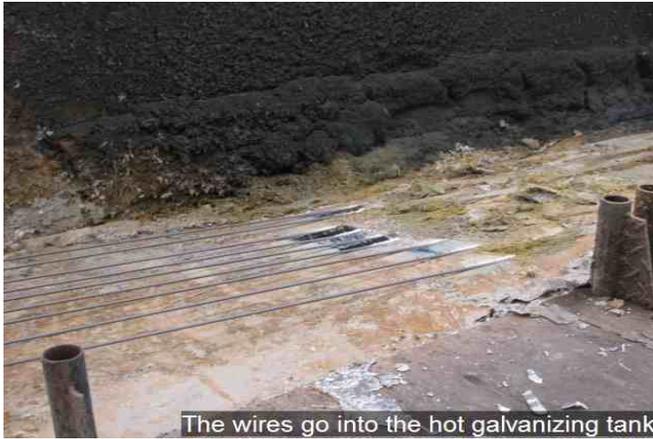
The wires go into the hot galvanizing tank

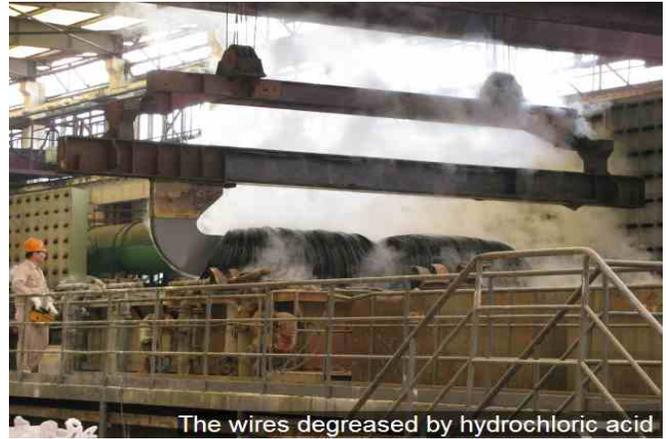
The wires degreased by hydrochloric acid

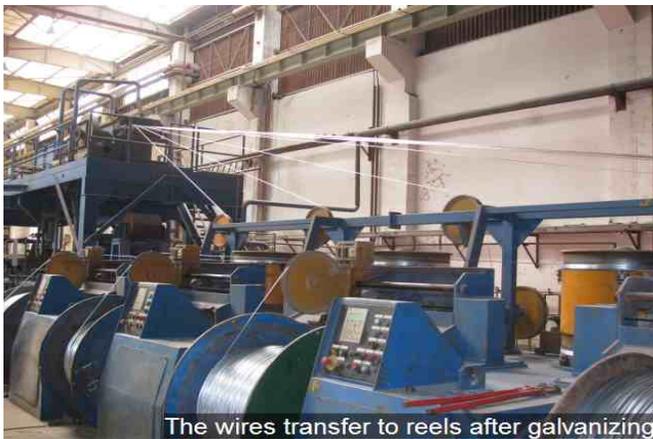
The wires transfer to reels after galvanizing
