DEPARTMENT OF TRANSPORTATION

Quality Assurance and Source Inspection

Contract #: 04-0120F4Cty: SF/ALA Rte: 80 PM: 13.2/13.9File #: 75.15**SOURCE INSPECTION REPORT****Resident Engineer:** Pursell, Gary**Address:** 333 Burma Road**City:** Oakland, CA 94607**Report No:** SIR-001915**Date Inspected:** 19-Mar-2010**Project Name:** SAS Superstructure**Prime Contractor:** American Bridge/Fluor Enterprises, a JV**Contractor:** Shanghai Pujiang Cable Co. (SPCC)**OSM Arrival Time:** 800**OSM Departure Time:** 1800**Location:** Bao Steel, Shanghai**Quality Control Contact:** Mr. Pei**Quality Control Present:** Yes No**Material transfer:** Yes No N/A**Sampled Items:** Yes No N/A**Stock Transfer:** Yes No N/A**OK to Cut:** Yes No N/A**Rebar Test Witness:** Yes No N/A**Delayed/Cancelled:** Yes No N/A**Other:** witnessed tensile tests for 5.4mm diameter**Bridge No:** 34-0006**Component:** 5.4mm diameter galvanized wire**Bid Item:** 66A**Lot No:** B240**Summary of Items Observed:**

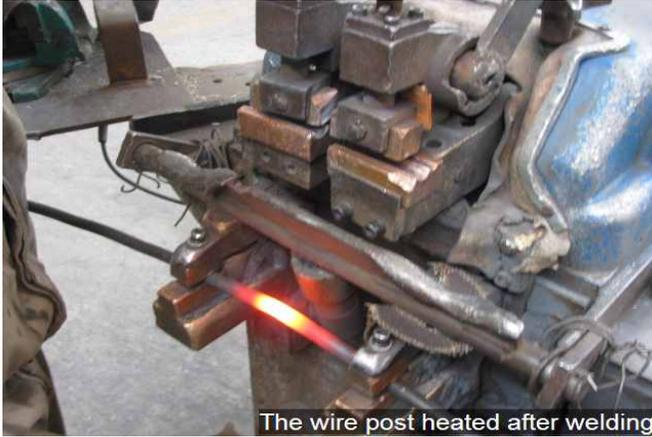
The wire post heated after welding

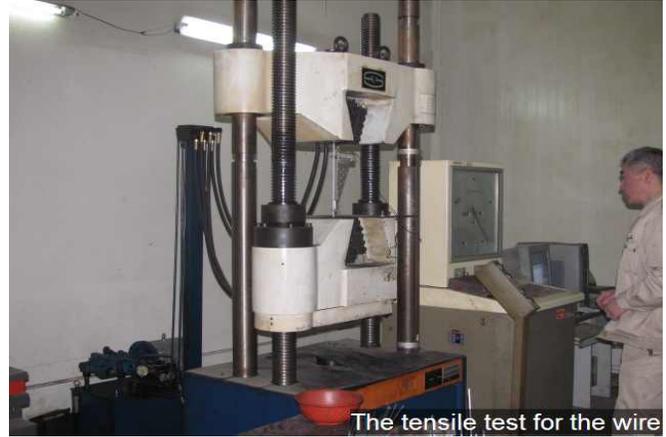
The tensile test for the wire

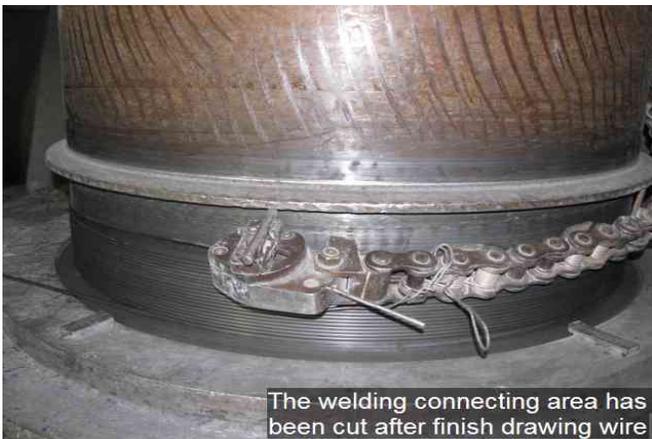
The welding connecting area has been cut after finish drawing wire

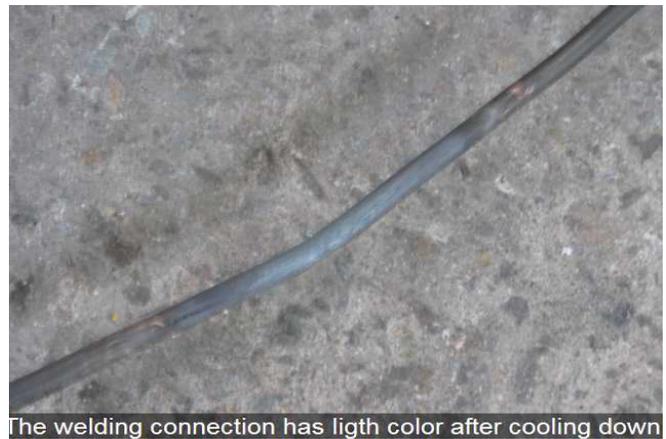
The welding connection has lighth color after cooling down
