**DEPARTMENT OF TRANSPORTATION**

Contract #: 04-0120F4Cty: SF/ALA Rte: 80 PM: 13.2/13.9File #: 69.15**SOURCE INSPECTION REPORT****Resident Engineer:** Pursell, Gary**Address:** 333 Burma Road**City:** Oakland, CA 94607**Report No:** SIR-002125**Date Inspected:** 26-Mar-2010**Project Name:** SAS Superstructure**OSM Arrival Time:** 700**Prime Contractor:** American Bridge/Fluor Enterprises, a JV**OSM Departure Time:** 1300**Contractor:** Zhenhua Port Machinery Company, Ltd (ZPMC), Changxing Island **Location:** Shanghai, China**Quality Control Contact:** Don Walter**Quality Control Present:** Yes No**Material transfer:** Yes No N/A**Sampled Items:** Yes No N/A**Stock Transfer:** Yes No N/A**OK to Cut:** Yes No N/A**Rebar Test Witness:** Yes No N/A**Delayed/Cancelled:** Yes No N/A**Other:****Bridge No:** 34-0006**Component:** OBG Components**Bid Item:****Lot No:** B-278**Summary of Items Observed:**

Inspection for Surface Preparation and/or Coating Application.

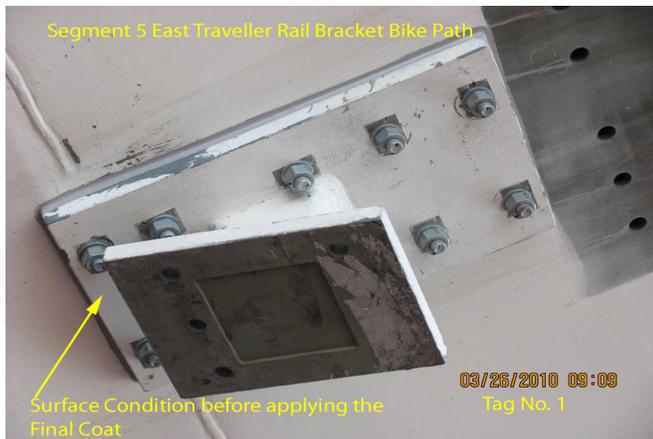
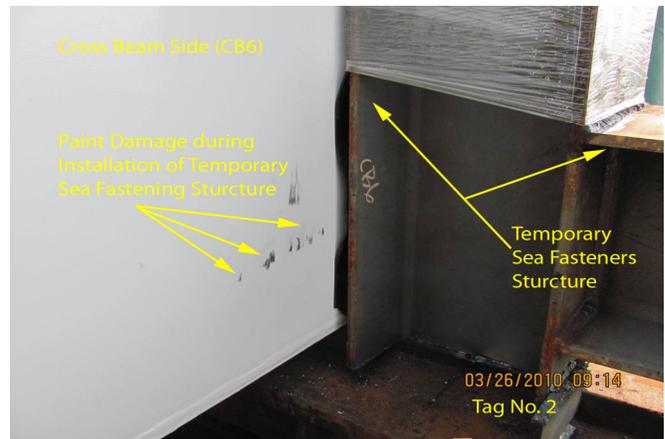
OBG External Traveler Bracket Inspection Request No. 3011

A joint three party inspection was performed by ZPMC QC's, ABF QA's and Caltrans QA for the OBG OBG External Assembled rail brackets for Lift 5 East at Shanghai Zhenhua Port Machinery Co., Ltd., (ZPMC) at ZPMC Ship No. 17.

Inspection Conclusions: Accepted after Cleaning the Surface by ABF QA's and Caltrans QA concurred with the ABF QA's Inspection.

Note: Please refer the attached pictures with Tag No. 1 for more comprehensive detail.
