DEPARTMENT OF TRANSPORTATION

Contract #: 04-0120F4Cty: SF/ALA Rte: 80 PM: 13.2/13.9File #: 69.15**SOURCE INSPECTION REPORT****Resident Engineer:** Pursell, Gary**Address:** 333 Burma Road**City:** Oakland, CA 94607**Report No:** SIR-002206**Date Inspected:** 07-May-2010**Project Name:** SAS Superstructure**OSM Arrival Time:** 700**Prime Contractor:** American Bridge/Fluor Enterprises, a JV**OSM Departure Time:** 1900**Contractor:** Zhenhua Port Machinery Company, Ltd (ZPMC), Changxing Island **Location:** Shanghai, China**Quality Control Contact:** Mr. Don Walton**Quality Control Present:** Yes No**Material transfer:** Yes No N/A**Sampled Items:** Yes No N/A**Stock Transfer:** Yes No N/A**OK to Cut:** Yes No N/A**Rebar Test Witness:** Yes No N/A**Delayed/Cancelled:** Yes No N/A**Other:** Coating Inspection**Bridge No:** 34-0006**Component:** See Below**Bid Item:** 77, 78, 79**Lot No:** B #204**Summary of Items Observed:**

SOURCE INSPECTION REPORT

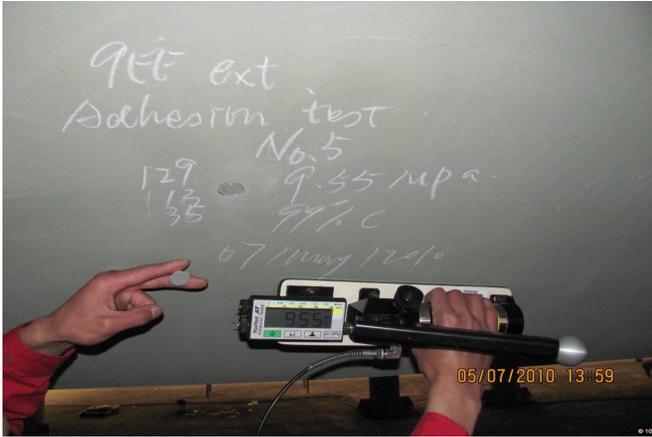
2. An inspection was requested on the OBG Segment 9EE for adhesion test vide request no. 3274 at Paint shop 1. This Caltrans inspector observed, ABF inspectors Mr. Turtle performing said inspection check. The results carried out with calibrated pull off adhesion tester found to be in the range of 5.73 MPA to 9.55Mpa which is acceptable as per contract documents. International protective coatings technical service representative Mr. Li peng was found present during the course of this inspection process. Photograph of Adhesion test carried out on Segment 9EE with 99% cohesion failure is attached.
