DEPARTMENT OF TRANSPORTATION

Office of Structural Materials

Contract #: 04-0120F4Cty: SF/ALA Rte: 80 PM: 13.2/13.9File #: 69.15**SOURCE INSPECTION REPORT****Resident Engineer:** Pursell, Gary**Address:** 333 Burma Road**City:** Oakland, CA 94607**Report No:** SIR-002207**Date Inspected:** 14-May-2010**Project Name:** SAS Superstructure**OSM Arrival Time:** 700**Prime Contractor:** American Bridge/Fluor Enterprises, a JV**OSM Departure Time:** 1900**Contractor:** Zhenhua Port Machinery Company, Ltd (ZPMC), Changxing Island **Location:** Shanghai, China**Quality Control Contact:** Mr. Don Walton**Quality Control Present:** Yes No**Material transfer:** Yes No N/A**Sampled Items:** Yes No N/A**Stock Transfer:** Yes No N/A**OK to Cut:** Yes No N/A**Rebar Test Witness:** Yes No N/A**Delayed/Cancelled:** Yes No N/A**Other:** Coating Inspection**Bridge No:** 34-0006**Component:** See Below**Bid Item:** 77, 78, 79**Lot No:** B #204**Summary of Items Observed:**

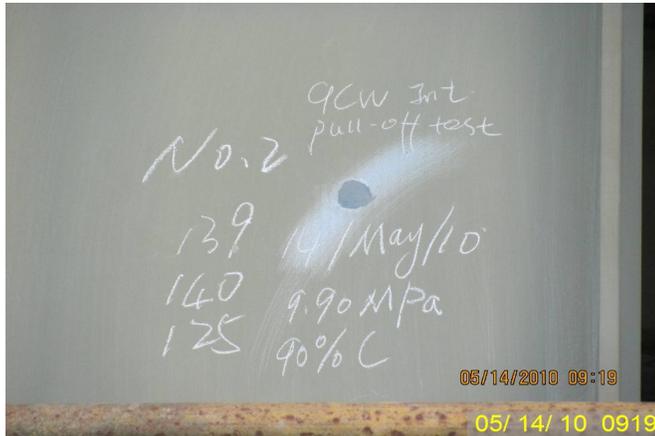
1. An inspection was requested on the OBG Segment 9CW for adhesion test of internal surfaces at the East Gate of the painting workshop no. 1, vide request no. 3303. This Caltrans inspector observed, ABF inspectors Mr. Stone and Mr. Wei performing the said inspection. The adhesion test was carried out in 7 places and the result found to be in the range of 7.21 Mpa with 100% cohesion to 15.65Mpa which is acceptable as per contract documents. International protective coatings technical service representative Mr. Li peng was found present during the course of this inspection process. (Photo of adhesion test carried out in internal surface no.2 with 90 % cohesion failure, and 9.9 Mpa is attached)

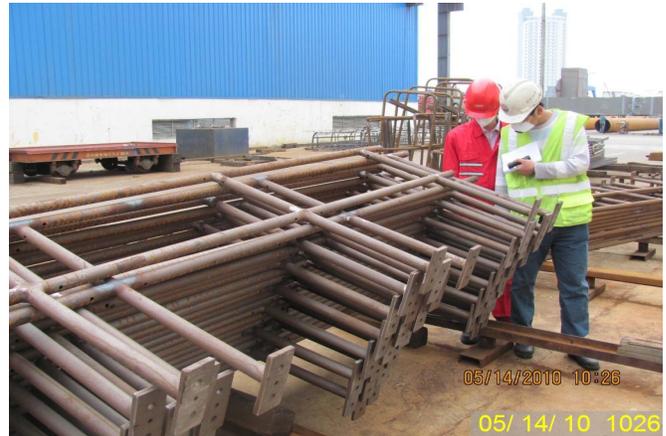
2. An inspection was requested on the OBG Catway handrail -78 nos for surface preparation inspection before dipping into the Zinc pot, vide request no. 3305 at Galvanizing workshop 1. This Caltrans inspector observed, ABF inspectors Mr. Sun performing said inspection check. This was found accepted by ABF Inspector which was subject to minor Grinding at marked places. International protective coatings technical service representative was not found present during the course of this inspection process. Photograph of some of the catway handrail is attached which was taken during Inspection.

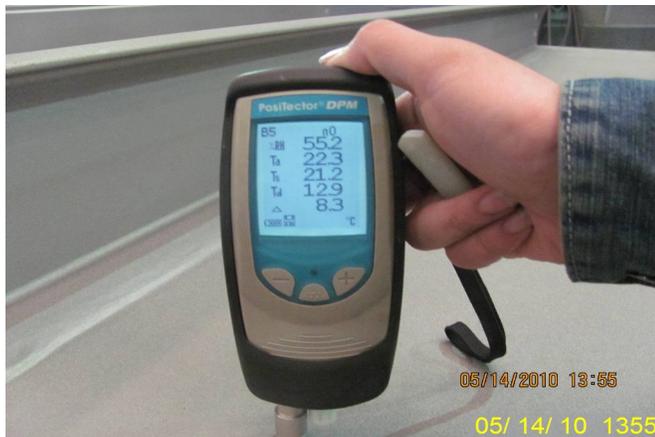
3. An inspection was requested on the OBG Segment 9DW for External support areas for surface preparation

inspection for the application of Interzinc 22 vide request no. 3304 at Paint shop 1. This Caltrans inspector observed, ABF inspectors Mr. Wei, Mr. Stone and Mr. Yui performing said inspection check. The Profile found to be 82 to 84um which is acceptable as per contract documents. The ambient conditions were monitored and found to be 8.3 deg. above dew point. The relative humidity found to be 55.2%. (Photo attached). International protective coatings technical service representative Mr. Li peng was found present during the course of this inspection process.
