DEPARTMENT OF TRANSPORTATION

Contract #: 04-0120F4Cty: SF/ALA Rte: 80 PM: 13.2/13.9File #: 69.15**SOURCE INSPECTION REPORT****Resident Engineer:** Pursell, Gary**Address:** 333 Burma Road**City:** Oakland, CA 94607**Report No:** SIR-002209**Date Inspected:** 21-May-2010**Project Name:** SAS Superstructure**OSM Arrival Time:** 700**Prime Contractor:** American Bridge/Fluor Enterprises, a JV**OSM Departure Time:** 1900**Contractor:** Zhenhua Port Machinery Company, Ltd (ZPMC), Changxing Island **Location:** Shanghai, China**Quality Control Contact:** Mr. Don Walton**Quality Control Present:** Yes No**Material transfer:** Yes No N/A**Sampled Items:** Yes No N/A**Stock Transfer:** Yes No N/A**OK to Cut:** Yes No N/A**Rebar Test Witness:** Yes No N/A**Delayed/Cancelled:** Yes No N/A**Other:** Coating Inspection**Bridge No:** 34-0006**Component:** See Below**Bid Item:** 77, 78, 79**Lot No:** B #204**Summary of Items Observed:**

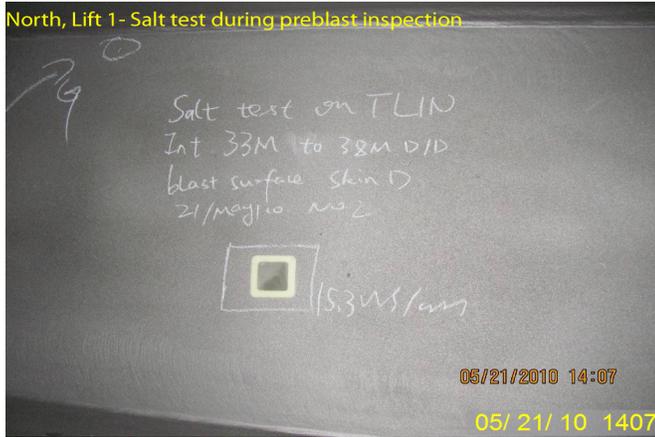
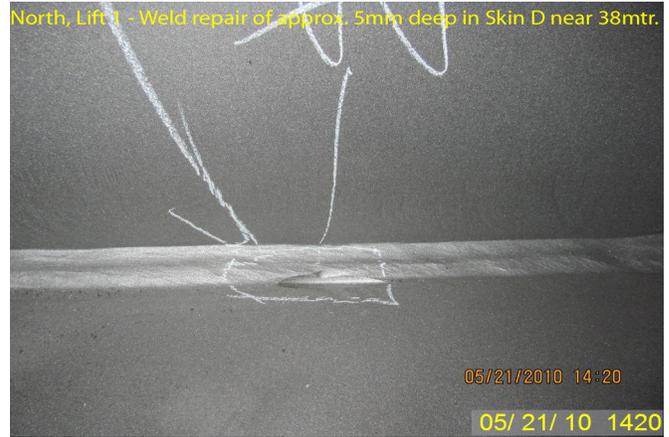
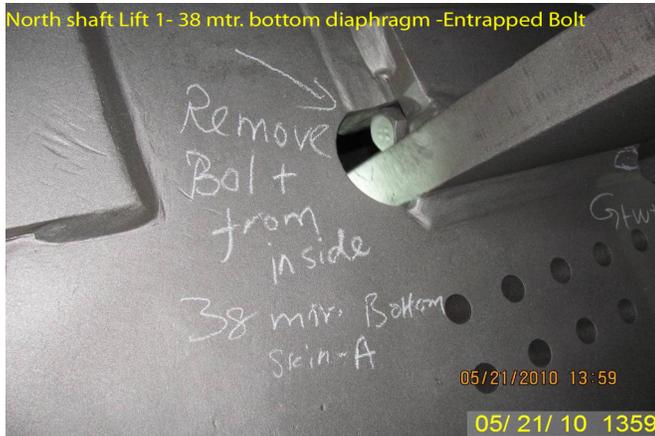
2. An inspection was requested for the Preblast inspection of North tower, Lift 1 internal surfaces from 38 mtr. top diaphragm to 50.3 mtr. tail end of the shaft, vide request no. T 434 at Blasting workshop no.1. This Caltrans inspector observed, ABF inspectors Mr. Don Walton, Mr. Sun and Mr. Shi stone performing said inspection check. Residual chlorides test has been conducted and the results found to be in the range of 15.3 us/cm to 21.4 us/cm which is acceptable as per contract documents. Photo of salt test conducted by ZPMC over Skin B near 38 mtr. elevation is attached. Several weld repair points for porosity, dent have been marked by ABF Inspectors and CT Inspector Mr. Chandra (B 247). These has to be marked for Magnetic particle testing (MT) after welding. One photo which shows the weld repair for a dent of approximately 5 mm deep in Skin D, near 38 mtr. elevation is attached with this report. Finally all the internal surfaces found rejected by ABF Inspectors for Grinding, grinding and MT and Weld repairs. It was observed that, a Bolt was entrapped in between fit lug in Skin A (AE Corner)

near 38 mtr. bottom diaphragm. Photo of the same is attached with this report. International protective coatings technical service representative was not found present during the course of this inspection process.
