DEPARTMENT OF TRANSPORTATION

Contract #: 04-0120F4Cty: SF/ALA Rte: 80 PM: 13.2/13.9File #: 69.15**SOURCE INSPECTION REPORT****Resident Engineer:** Pursell, Gary**Address:** 333 Burma Road**City:** Oakland, CA 94607**Report No:** SIR-002476**Date Inspected:** 10-Jul-2010**Project Name:** SAS Superstructure**OSM Arrival Time:** 700**Prime Contractor:** American Bridge/Fluor Enterprises, a JV**OSM Departure Time:** 1900**Contractor:** Zhenhua Port Machinery Company, Ltd (ZPMC), Changxing Island **Location:** Shanghai, China**Quality Control Contact:** Mr. Don Walton**Quality Control Present:** Yes No**Material transfer:** Yes No N/A**Sampled Items:** Yes No N/A**Stock Transfer:** Yes No N/A**OK to Cut:** Yes No N/A**Rebar Test Witness:** Yes No N/A**Delayed/Cancelled:** Yes No N/A**Other:** Coating Inspection**Bridge No:** 34-0006**Component:** See Below**Bid Item:** 77, 78, 79**Lot No:** B #204**Summary of Items Observed:**

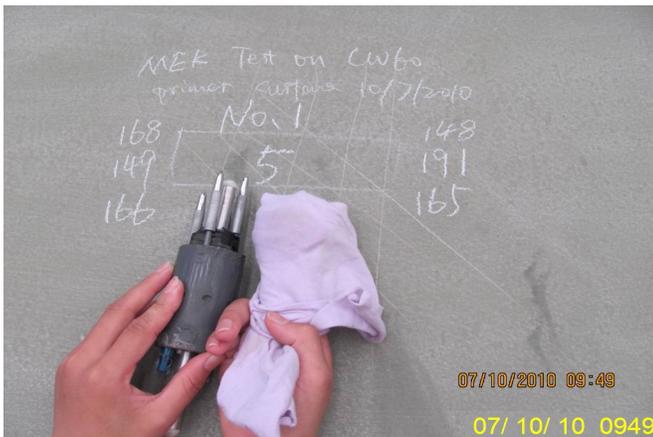
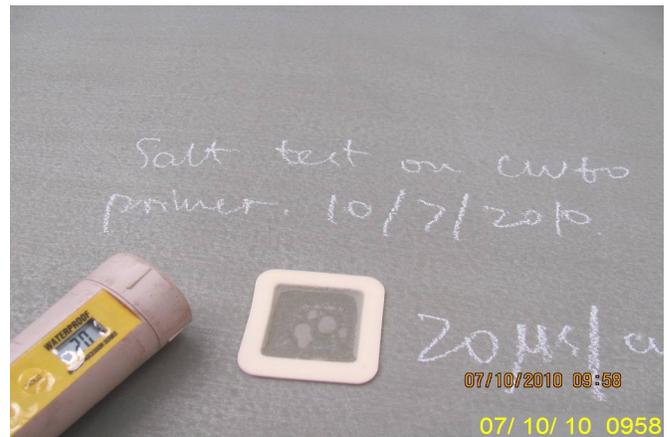
1. An inspection was requested on the OBG Counter weight (CW) External primer repaired areas -CW 60, CW External surface -11 sets for MEK Pencil hardness test of Mist coating, CW Cover plate external surface -CW 46 to CW 70 -26 PCS and Bike path external surfaces -2 sets vide request no. 3638 at Painting shop 1& 2. This Caltrans inspector observed, ABF inspectors Mr. Shi stone, and Mr. Hong Cai yan performing said inspection check. It was observed that, These surfaces were accepted for finish coat by ABF Inspectors. The result of Salt test found to be 20 us/cm and MEK test found to be in Grade 5 at 2 places which is acceptable as per contract documents. The ambient conditions were monitored and is 5 deg. above dew point and the relative humidity found to be 83.2% which is acceptable as per contract documents. International protective coatings technical service representative Mr. Lou Qian Chuan was found present during the course of this inspection process. (Photograph showing Results of MEK test and Salt test inspection is attached)
