DEPARTMENT OF TRANSPORTATION

Office of Structural Materials

Contract #: 04-0120F4Cty: SF/ALA Rte: 80 PM: 13.2/13.9File #: 69.15**SOURCE INSPECTION REPORT****Resident Engineer:** Pursell, Gary**Address:** 333 Burma Road**City:** Oakland, CA 94607**Report No:** SIR-002506**Date Inspected:** 19-Jul-2010**Project Name:** SAS Superstructure**OSM Arrival Time:** 700**Prime Contractor:** American Bridge/Fluor Enterprises, a JV**OSM Departure Time:** 1900**Contractor:** Zhenhua Port Machinery Company, Ltd (ZPMC), Changxing Island **Location:** Shanghai, China**Quality Control Contact:** Mr. Don Walton**Quality Control Present:** Yes No**Material transfer:** Yes No N/A**Sampled Items:** Yes No N/A**Stock Transfer:** Yes No N/A**OK to Cut:** Yes No N/A**Rebar Test Witness:** Yes No N/A**Delayed/Cancelled:** Yes No N/A**Other:** Coating Inspection**Bridge No:** 34-0006**Component:** See Below**Bid Item:** 77, 78, 79**Lot No:** B #204**Summary of Items Observed:**

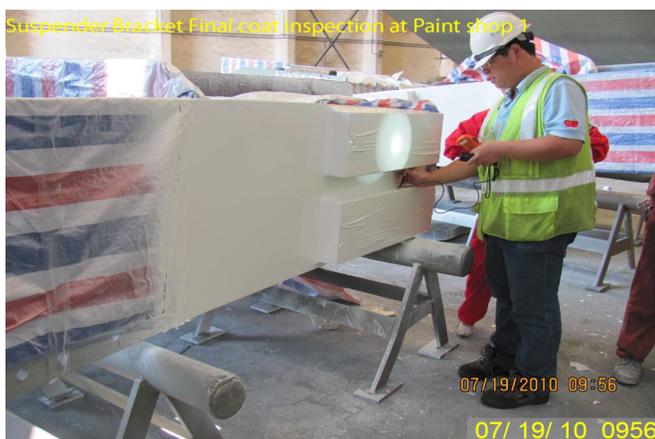
1. An inspection was requested on the OBG Suspender Bracket external one end after Finish Coating, vide request no. 3739 at Painting Shop 1. This QA inspector observed, Mr. Shi Stone from ABF carrying out DFT of the finish coat and found within the the range of 230 to 320 microns which is acceptable as per contract documents. The suspender Brackets offered for inspection are SB 48E, SB 48W, SB52W, SB54W, SB56E, SB60E -6 nos. International protective coatings technical service representative was not found present during the course of this inspection process. (Photo attached)

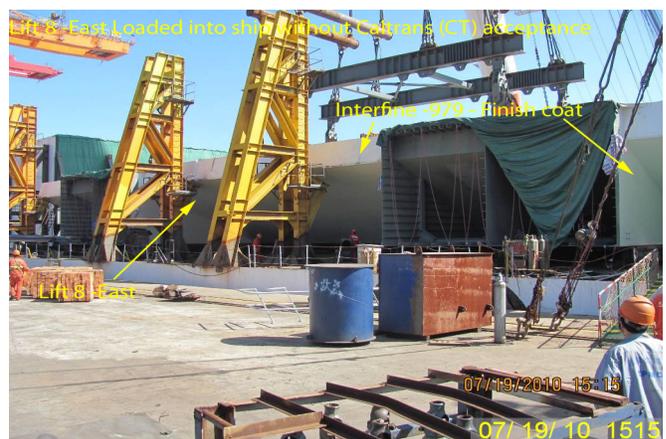
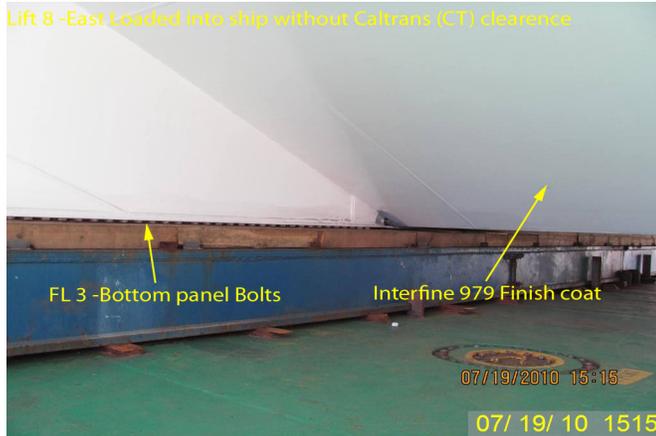
5. During Quality Assurance (QA) random in-process coatings observation, this Quality Assurance Inspector (QA) observed, Lift 8 –East Loaded into ship at Port no. 5 –Heavy Dock jetty without Caltrans (CT) Final acceptance. External Interfine 979 Finish was rejected 3 times by Caltrans Engineer Mr. Aaron Prichlik for Low DFT, Grit contamination, Orange peeling and Dry spray.The date and Notification nos of earlier rejections are 17 July 2010(2 times by notification nos 3709 and 3712), on 12 July 2010, notification no. 3666, respectively. After loading the access for bottom plate in Lift 8 E for finish coat inspection found to be approximately 600 mm. Also, No access for Bottom support areas and FL3 Bottom panel bolt touch up areas- finish coat inspection. This QA inspector wrote an Incident Report. (Photo attached)
