**DEPARTMENT OF TRANSPORTATION**

Office of Structural Materials

Contract #: 04-0120F4Cty: SF/ALA Rte: 80 PM: 13.2/13.9File #: 69.15**SOURCE INSPECTION REPORT****Resident Engineer:** Pursell, Gary**Address:** 333 Burma Road**City:** Oakland, CA 94607**Report No:** SIR-002512**Date Inspected:** 16-Jul-2010**Project Name:** SAS Superstructure**OSM Arrival Time:** 700**Prime Contractor:** American Bridge/Fluor Enterprises, a JV**OSM Departure Time:** 1900**Contractor:** Zhenhua Port Machinery Company, Ltd (ZPMC), Changxing Island **Location:** Shanghai, China**Quality Control Contact:** Mr. Don Walton**Quality Control Present:** Yes No**Material transfer:** Yes No N/A**Sampled Items:** Yes No N/A**Stock Transfer:** Yes No N/A**OK to Cut:** Yes No N/A**Rebar Test Witness:** Yes No N/A**Delayed/Cancelled:** Yes No N/A**Other:** Coating Inspection**Bridge No:** 34-0006**Component:** See Below**Bid Item:** 77, 78, 79**Lot No:** B #204**Summary of Items Observed:**

# SOURCE INSPECTION REPORT

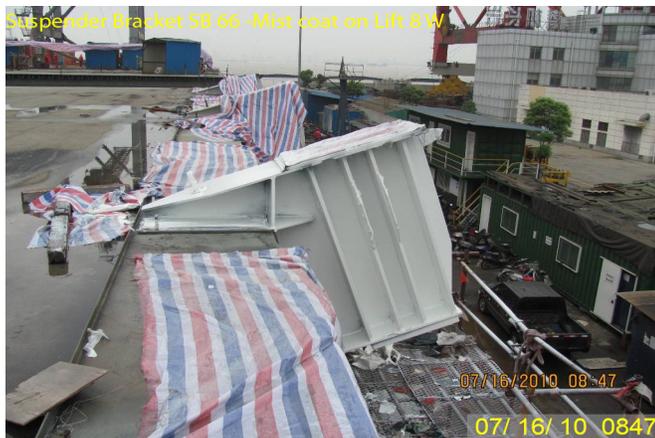
3. During Quality Assurance (QA) random in-process observations, this Quality Assurance Inspector found Suspender Bracket no. SB66W, over coated with Interfine 979 –Mist coat, after exceeding the Overcoat interval, which is 14 days after Interzinc 22 application. This suspender Bracket found Erected on Lift 8, West, Deck panel in OBG assembly yard. As per contract documents, Surface preparation and Painting procedure Doc no. PQWP-P-001, Revision 4 –Section 8.3.9 – The Maximum interval of Over coating between Interzinc 22 and Interfine 979 should not exceed 14 days.This QA Inspector wrote Incident report. (Photo of suspender Bracket -SB 66 is attached)
