DEPARTMENT OF TRANSPORTATION

Quality Assurance and Source Inspection

Contract #: 04-0120F4Cty: SF/ALA Rte: 80 PM: 13.2/13.9File #: 69.15**SOURCE INSPECTION REPORT****Resident Engineer:** Pursell, Gary**Address:** 333 Burma Road**City:** Oakland, CA 94607**Report No:** SIR-002524**Date Inspected:** 20-Jul-2010**Project Name:** SAS Superstructure**OSM Arrival Time:** 700**Prime Contractor:** American Bridge/Fluor Enterprises, a JV**OSM Departure Time:** 1900**Contractor:** Zhenhua Port Machinery Company, Ltd (ZPMC), Changxing Island **Location:** Shanghai, China**Quality Control Contact:** Mr. Don Walton**Quality Control Present:** Yes No**Material transfer:** Yes No N/A**Sampled Items:** Yes No N/A**Stock Transfer:** Yes No N/A**OK to Cut:** Yes No N/A**Rebar Test Witness:** Yes No N/A**Delayed/Cancelled:** Yes No N/A**Other:** Coating Inspection**Bridge No:** 34-0006**Component:** See Below**Bid Item:** 77, 78, 79**Lot No:** B #204**Summary of Items Observed:**

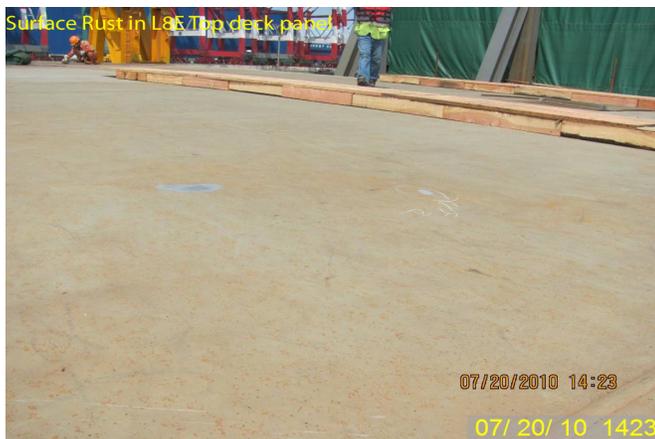
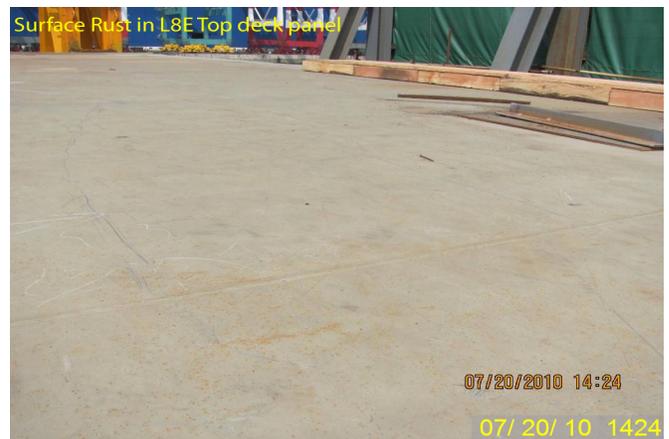
5. An inspection was requested on the OBG External Top Deck, L8E, vide request no. 3753 at Ship no.9, Heavy Dock Jetty. This QA inspector observed, ABF inspectors Mr. Wei, Mr. Hong and Mr. Sun performing the said inspection and Rejected the same for Surface rust. This QA Inspector observed that, sand paper applied to remove these rust, but only in few areas. Numerous places, this surface rust found not removed. It was also observed that, Wooden pieces kept on Deck panel at Several places. Hence these areas are not accessible for inspection of Top surface. International protective coatings technical service representative Mr. Lou Qian Chuan. was found present during the coarse of this inspection process. As per IP Representative, these rust is not a major issue, once its removed completely in all areas.(Photo of Surface rust in Deck panel is attached)

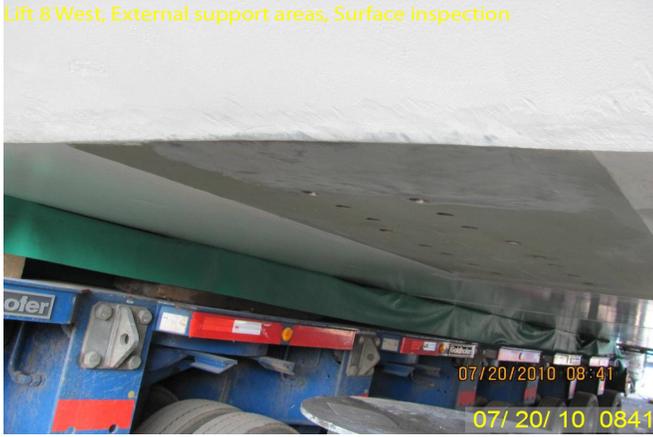
6. An inspection was requested on the OBG External support areas (L8W), vide request no. 3747 at OBG assembly yard. This QA inspector observed, ABF inspectors Mr. Wei performing the said inspection and accepted the same after cleaning the edges of the surface with sand paper. The profile test conducted at 3 places found to be in the range of 37 to 46 microns which is acceptable as per Contract Documents. International protective coatings technical service representative Mr. Lou Qian Chuan was found present during the coarse of this inspection process.

Lift 8 West, External support areas, Surface inspection

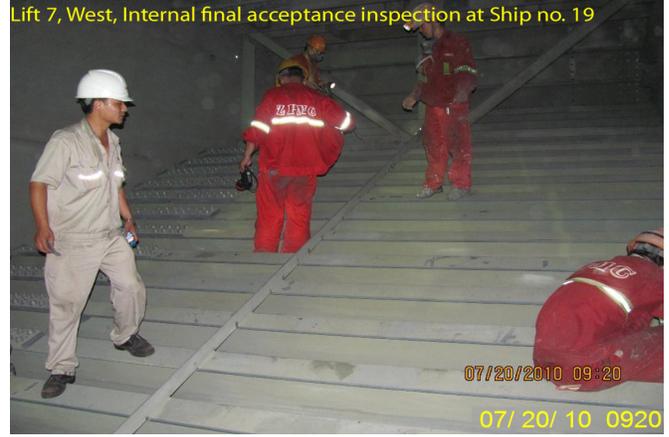
1. An inspection was requested on the OBG internal entire floor from P.P 50 to P.P 51 and P.P 53 to P.P 55 (L7W)- 3 Sections, vide request no. 3757 at Heavy Dock Jetty, Port no. 5. This QA inspector observed, ABF inspectors Mr. Sun, Mr. Wei and Mr. Hong performing the said inspection and accepted all sections after cleaning the surfaces by vacuum cleaner. This acceptance is subject to caulking has to be carried out in last stage of shipment. International protective coatings technical service representative Mr. Lou Qian Chuan. was found present during the course of this inspection process. (Photo attached)

Lift 7, West, Internal final acceptance inspection at Ship no. 19
