DEPARTMENT OF TRANSPORTATION

Contract #: 04-0120F4Cty: SF/ALA Rte: 80 PM: 13.2/13.9File #: 69.15**SOURCE INSPECTION REPORT****Resident Engineer:** Pursell, Gary**Address:** 333 Burma Road**City:** Oakland, CA 94607**Report No:** SIR-002525**Date Inspected:** 22-Jul-2010**Project Name:** SAS Superstructure**OSM Arrival Time:** 700**Prime Contractor:** American Bridge/Fluor Enterprises, a JV**OSM Departure Time:** 1900**Contractor:** Zhenhua Port Machinery Company, Ltd (ZPMC), Changxing Island **Location:** Shanghai, China**Quality Control Contact:** Mr. Don Walton**Quality Control Present:** Yes No**Material transfer:** Yes No N/A**Sampled Items:** Yes No N/A**Stock Transfer:** Yes No N/A**OK to Cut:** Yes No N/A**Rebar Test Witness:** Yes No N/A**Delayed/Cancelled:** Yes No N/A**Other:** Coating Inspection**Bridge No:** 34-0006**Component:** See Below**Bid Item:** 77, 78, 79**Lot No:** B #204**Summary of Items Observed:**

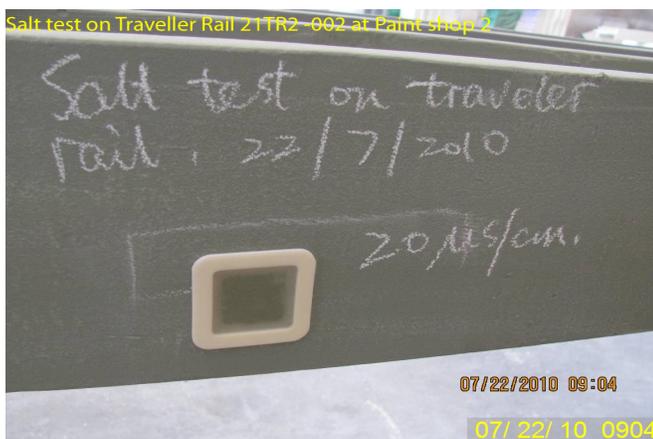
1. An inspection was requested on the OBG Traveler Rail -21TR2-002, 21 TR3-003 -2 nos, vide request no. 3778 at Painting workshop 2 for MEK, Pencil hardness test of Primer coat for Mist coat application. This QA inspector observed, ABF inspector Mr. Shi stone performing the said inspection and accepted the same after observing the profile rane from 80 to 147 microns, which is acceptable as per Contract documents. Salt test conducted at 1 place and the result found to be 20us/cm. The pencil hardness test result found to be in the grade of 5. The salt test and MEK test result found to be acceptable as per contract documents. The ambient conditions were measured and is 7.5 deg. above dew point and the Relative humidity found to be 68.1% which is acceptable as per contract documents. International protective coatings technical service representative was not present during the course of this inspection process. (Photo of Salt test result and ambient condition measurement is attached)
