**DEPARTMENT OF TRANSPORTATION**

Office of Structural Materials

Contract #: 04-0120F4Cty: SF/ALA Rte: 80 PM: 13.2/13.9File #: 69.15**SOURCE INSPECTION REPORT****Resident Engineer:** Pursell, Gary**Address:** 333 Burma Road**City:** Oakland, CA 94607**Report No:** SIR-002557**Date Inspected:** 30-Jul-2010**Project Name:** SAS Superstructure**OSM Arrival Time:** 700**Prime Contractor:** American Bridge/Fluor Enterprises, a JV**OSM Departure Time:** 1900**Contractor:** Zhenhua Port Machinery Company, Ltd (ZPMC), Changxing Island **Location:** Shanghai, China**Quality Control Contact:** Mr. Don Walton**Quality Control Present:** Yes No**Material transfer:** Yes No N/A**Sampled Items:** Yes No N/A**Stock Transfer:** Yes No N/A**OK to Cut:** Yes No N/A**Rebar Test Witness:** Yes No N/A**Delayed/Cancelled:** Yes No N/A**Other:** Coating Inspection**Bridge No:** 34-0006**Component:** See Below**Bid Item:** 77, 78, 79**Lot No:** B #204**Summary of Items Observed:**

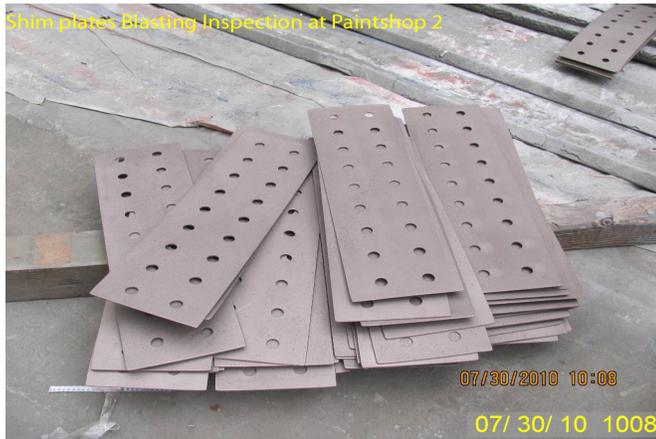
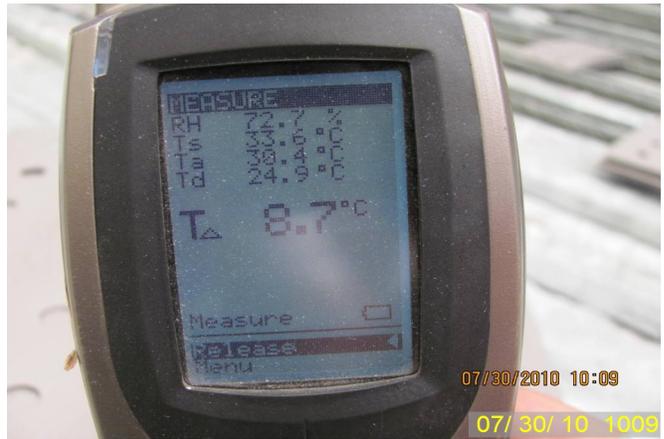
1. An inspection was requested on the OBG Shim plates, GGL-MQ-1728 -92 nos, vide request no. 3892 at Painting workshop 2 for Surface preparation inspection. This QA inspector observed, ABF inspector Mr. Vince and Mr. Sun performing the said inspection and accepted the same. The X3 profile observed ranged from 80 to 84 microns, which is acceptable as per Contract documents. The ambient conditions were measured and is 8.7 deg. above dew point and the Relative humidity found to be 72.7% which is acceptable as per contract documents. International protective coatings technical service representative was not present during the course of this inspection process. (Photo of Shim plates and ambient condition measurement is attached)
