DEPARTMENT OF TRANSPORTATION

Contract #: 04-0120F4Cty: SF/ALA Rte: 80 PM: 13.2/13.9File #: 69.15**SOURCE INSPECTION REPORT****Resident Engineer:** Pursell, Gary**Address:** 333 Burma Road**City:** Oakland, CA 94607**Report No:** SIR-002619**Date Inspected:** 27-Aug-2010**Project Name:** SAS Superstructure**OSM Arrival Time:** 700**Prime Contractor:** American Bridge/Fluor Enterprises, a JV**OSM Departure Time:** 1900**Contractor:** Zhenhua Port Machinery Company, Ltd (ZPMC), Changxing Island **Location:** Shanghai, China**Quality Control Contact:** Mr. Don Walton**Quality Control Present:** Yes No**Material transfer:** Yes No N/A**Sampled Items:** Yes No N/A**Stock Transfer:** Yes No N/A**OK to Cut:** Yes No N/A**Rebar Test Witness:** Yes No N/A**Delayed/Cancelled:** Yes No N/A**Other:** Coating Inspection**Bridge No:** 34-0006**Component:** See Below**Bid Item:** 77, 78, 79**Lot No:** B #204**Summary of Items Observed:**

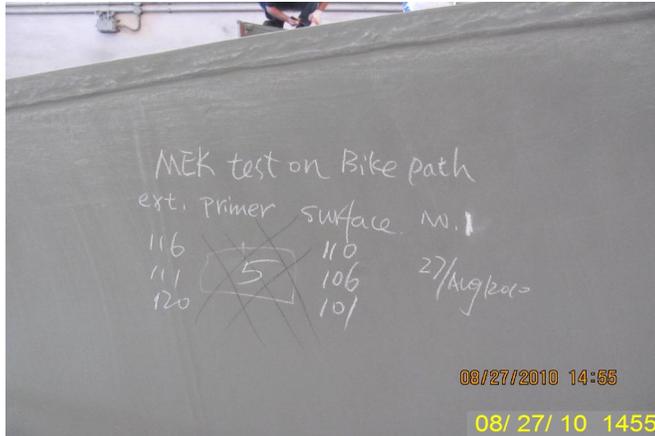
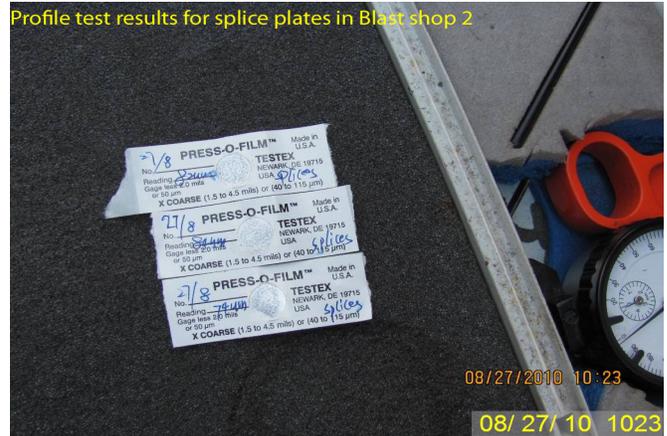
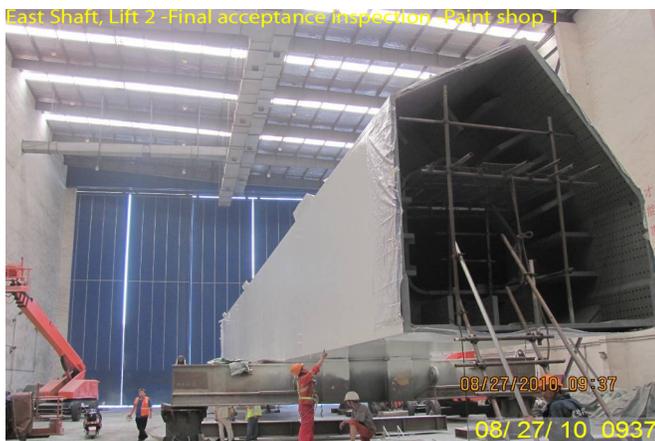
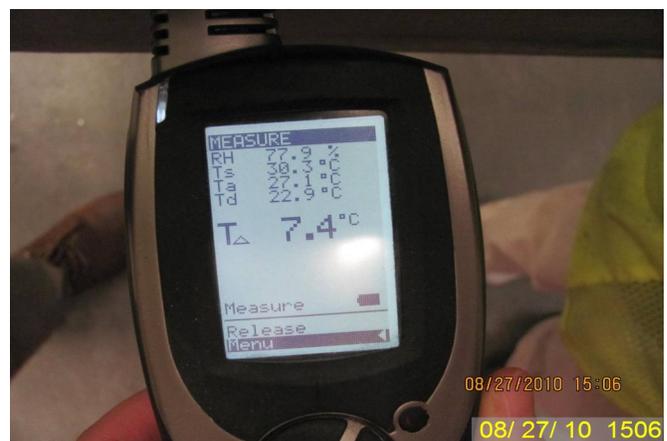
4. An inspection was requested on the OBG Bike path external surface -7 sets (BK 001-037, 38, 39, 40, 41, 42, 43 - for DFT check inspection after Interzinc 22 application, Residual chlorides test and MEK test, vide inspection request no. 4076 at paint shop 2. This QA inspector observed, ABF inspector Mr. Sun, Mr. Stone and Mr. Hong inspecting all the surfaces. This was found accepted by ABF Inspector, after observing the DFT which ranges from 92 to 175 microns which is acceptable as per contract documents. Residual chloride test have been conducted in one place and the result found to be 20US/CM, MEK test conducted in 3 places and the result found to be in the Grade of 5. The MEK and Salt test result found to be acceptable as per contract documents. Ambient conditions were monitored and found to be 7.4 deg. above due point and the relative humidity found to be 77.9 % which is acceptable as per contract documents. International protective coatings technical service representative was not found present during the coarse of this inspection process. (Photo of Ambient condition, result of Salt test and MEK test is attached)
