DEPARTMENT OF TRANSPORTATION

Contract #: 04-0120F4Cty: SF/ALA Rte: 80 PM: 13.2/13.9File #: 69.15**SOURCE INSPECTION REPORT****Resident Engineer:** Siegenthaler, Peter**Address:** 333 Burma Road**City:** Oakland, CA 94607**Report No:** SIR-002642**Date Inspected:** 02-Sep-2010**Project Name:** SAS Superstructure**OSM Arrival Time:** 700**Prime Contractor:** American Bridge/Fluor Enterprises, a JV**OSM Departure Time:** 1900**Contractor:** Zhenhua Port Machinery Company, Ltd (ZPMC), Changxing Island **Location:** Shanghai, China**Quality Control Contact:** Mr. Don Walton**Quality Control Present:** Yes No**Material transfer:** Yes No N/A**Sampled Items:** Yes No N/A**Stock Transfer:** Yes No N/A**OK to Cut:** Yes No N/A**Rebar Test Witness:** Yes No N/A**Delayed/Cancelled:** Yes No N/A**Other:** Coating Inspection**Bridge No:** 34-0006**Component:** See Below**Bid Item:** 77, 78, 79**Lot No:** B # 204**Summary of Items Observed:**

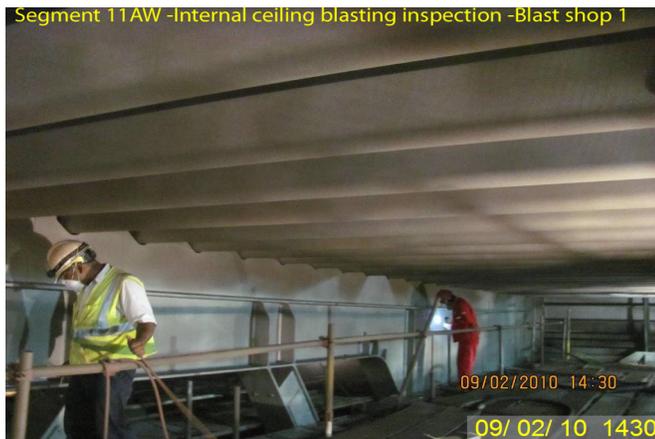
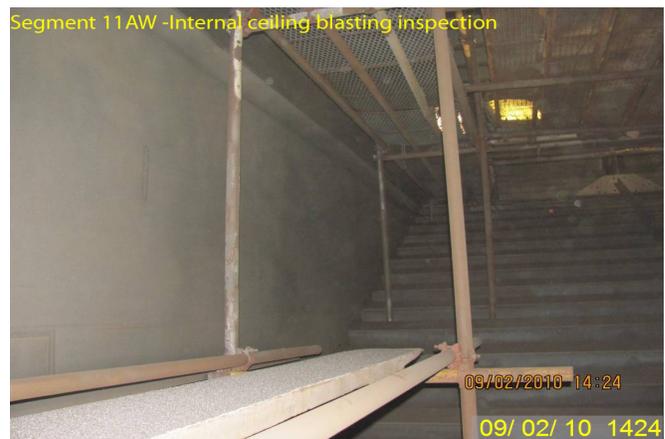
1. An inspection was requested on the OBG segment 11AW, internal entire ceiling (3 sections) for Surface preparation inspection and Residual chlorides test, vide request no. 4141 at Blast shop 1. This QA inspector observed, ABF inspectors Mr. Stone, Mr. Turtle and Mr. Helen performing the said inspection. This Caltrans inspector observed, Mr. Vibin (B 294), Mr. Chandra (B 247), Mr. Tim McClendon (B 290), Mr. Bera (B 205) and Mr. Pillai (B286) from CT were present during the inspection and they marked all the Grinding points, Grinding +MT and weld repair points. This QA inspector observed, ABF inspectors rejected all internal surfaces for Overblast and poor blasting. This was again offered for inspection vide notification no. 4144 and 4148. This was found rejected again by ABF inspectors for low profile and irregular profile in some places. For third time after attending these profile points, ZPMC found offered for inspection again vide notification no. 4149 and accepted by ABF inspectors. The surface profile measured by ZPMC QC inspectors found to be in the range of 76 to 85 which is acceptable as per contract documents. International protective coatings technical service representative Mr. Lou Qian Chuan. was found present during the course of this inspection process. (Photo attached)
