DEPARTMENT OF TRANSPORTATION

Quality Assurance and Source Inspection

Contract #: 04-0120F4Cty: SF/ALA Rte: 80 PM: 13.2/13.9File #: 69.15**SOURCE INSPECTION REPORT****Resident Engineer:** Siegenthaler, Peter**Address:** 333 Burma Road**City:** Oakland, CA 94607**Report No:** SIR-002643**Date Inspected:** 03-Sep-2010**Project Name:** SAS Superstructure**OSM Arrival Time:** 700**Prime Contractor:** American Bridge/Fluor Enterprises, a JV**OSM Departure Time:** 1900**Contractor:** Zhenhua Port Machinery Company, Ltd (ZPMC), Changxing Island **Location:** Shanghai, China**Quality Control Contact:** Mr. Don Walton**Quality Control Present:** Yes No**Material transfer:** Yes No N/A**Sampled Items:** Yes No N/A**Stock Transfer:** Yes No N/A**OK to Cut:** Yes No N/A**Rebar Test Witness:** Yes No N/A**Delayed/Cancelled:** Yes No N/A**Other:** Coating Inspection**Bridge No:** 34-0006**Component:** See Below**Bid Item:** 77, 78, 79**Lot No:** B #204**Summary of Items Observed:**

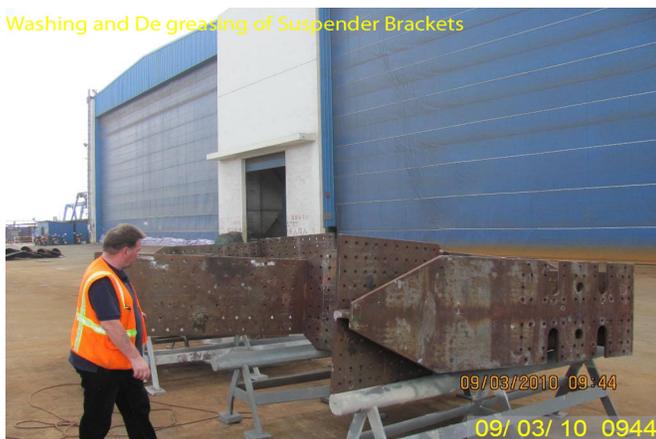
3. An inspection was requested on the Suspender Brackets -SB 84E and SB84W for Washing and Degreasing at West Gate of the Blasting shop , vide inspection request no. 4159 . This QA inspector observed, ABF inspector Mr. Don Walton and Mr. Stone inspecting all the surfaces. This was found accepted by ABF Inspectors. International protective coatings technical service representative Mr. Lou Qian Chuan was found present during the course of this inspection process. (Photo attached)

Washing and Degreasing of Suspender Brackets

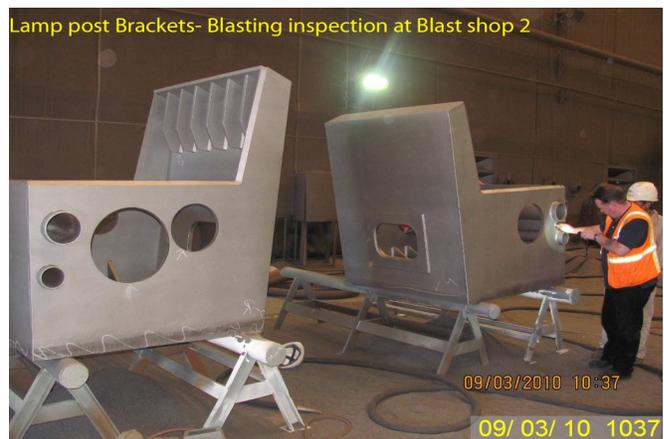
2. An inspection was requested on the OBG Splices -816 pieces and Lamp support brackets -3 nos (LB3-002, LB3-003, LB4-002) at Blast shop 2, vide inspection request no. 4158 for Surface preparation inspection and Residual chlorides test inspection. This QA inspector observed, ABF inspector Mr. Don Walton and Mr. Stone inspecting all the surfaces. This was found accepted by ABF Inspectors, after minor Reblast for splices. Lamp support brackets found rejected by ABF Inspectors for grinding and edge repairs. 3 nos of Weld repair have been informed to Mr. Art Peterson (B 273) and he took a note of that in the drawing. X 3 profile found in the range of 74 to 85 microns and salt test result found to be 30us/cm which is acceptable as per contract documents. International protective coatings technical service representative Mr. Lou Qian Chuan was found present during the course of this inspection process. (Photo of lamp support bracket during blasting inspection is attached)

Lamp post Brackets- Blasting inspection at Blast shop 2
