**DEPARTMENT OF TRANSPORTATION**

Office of Structural Materials

Contract #: 04-0120F4Cty: SF/ALA Rte: 80 PM: 13.2/13.9File #: 69.15**SOURCE INSPECTION REPORT****Resident Engineer:** Siegenthaler, Peter**Address:** 333 Burma Road**City:** Oakland, CA 94607**Report No:** SIR-002644**Date Inspected:** 10-Sep-2010**Project Name:** SAS Superstructure**OSM Arrival Time:** 700**Prime Contractor:** American Bridge/Fluor Enterprises, a JV**OSM Departure Time:** 1900**Contractor:** Zhenhua Port Machinery Company, Ltd (ZPMC), Changxing Island **Location:** Shanghai, China**Quality Control Contact:** Mr. Don Walton**Quality Control Present:** Yes No**Material transfer:** Yes No N/A**Sampled Items:** Yes No N/A**Stock Transfer:** Yes No N/A**OK to Cut:** Yes No N/A**Rebar Test Witness:** Yes No N/A**Delayed/Cancelled:** Yes No N/A**Other:** Coating Inspection**Bridge No:** 34-0006**Component:** See Below**Bid Item:** 77, 78, 79**Lot No:** B #204**Summary of Items Observed:**

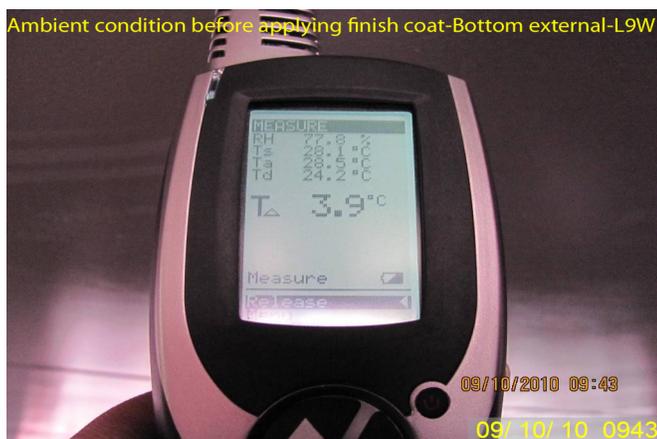
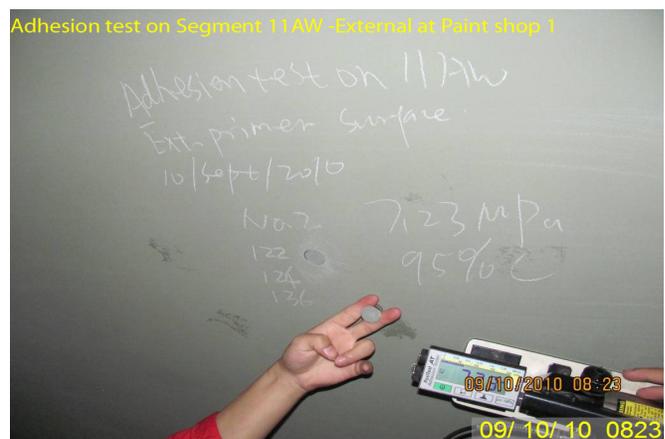
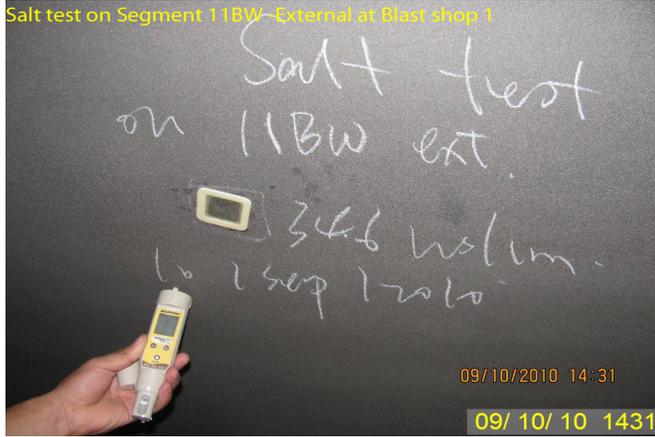
2. An inspection was requested on the OBG Cross beam side corner unit, External surface and Bottom plate of Lift 9 West, vide inspection request no. 4240 for DFT check before Finish coat application. This QA inspector observed, ABF inspector Mr. Don Walton and Mr. Wei and Mr. Helen inspecting all the surfaces. This was found accepted by ABF Inspectors, after cleaning down some surfaces for stain and dust. Temporary attachment on Cross beam bottom plate requires removal. Ambient conditions measured and found 3.9 deg. above dew point and the relative humidity found to be 77% which is acceptable as per contract documents. International protective coatings technical service representative Mr. Li Peng was found present during the course of this inspection process. (Photo of Ambient conditions measured by ZPMC QC inspectors is attached)
