DEPARTMENT OF TRANSPORTATION

Office of Structural Materials

Quality Assurance and Source Inspection

Contract #: 04-0120F4Cty: SF/ALA Rte: 80 PM: 13.2/13.9File #: 69.15**SOURCE INSPECTION REPORT****Resident Engineer:** Siegenthaler, Peter**Address:** 333 Burma Road**City:** Oakland, CA 94607**Report No:** SIR-002655**Date Inspected:** 17-Sep-2010**Project Name:** SAS Superstructure**OSM Arrival Time:** 700**Prime Contractor:** American Bridge/Fluor Enterprises, a JV**OSM Departure Time:** 1900**Contractor:** Zhenhua Port Machinery Company, Ltd (ZPMC), Changxing Island **Location:** Shanghai, China**Quality Control Contact:** Mr. Don Walton**Quality Control Present:** Yes No**Material transfer:** Yes No N/A**Sampled Items:** Yes No N/A**Stock Transfer:** Yes No N/A**OK to Cut:** Yes No N/A**Rebar Test Witness:** Yes No N/A**Delayed/Cancelled:** Yes No N/A**Other:** Coating Inspection**Bridge No:** 34-0006**Component:** See Below**Bid Item:** 77, 78, 79**Lot No:** B #204**Summary of Items Observed:**

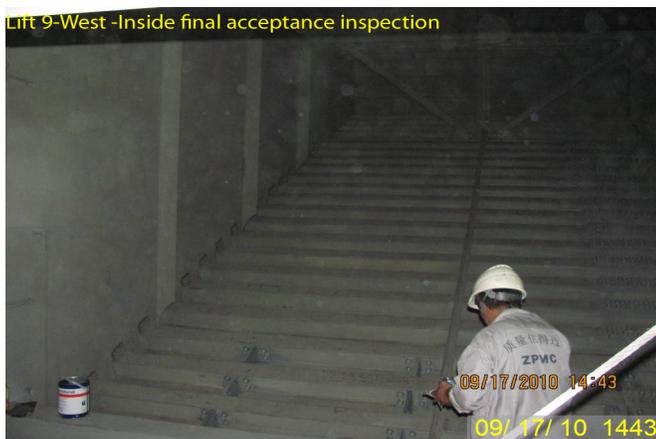
1. An inspection was requested on the OBG internal entire floor from the pre weld seam to P.P 78 of Lift 9 West, 7 sections, vide inspecton request no. 4355 for DFT check and final acceptance inspection prior to transport from ZPMC at Ship no. 18, Heavy Dock. This QA inspector observed, ABF inspector Mr. Don Walton and Mr. Wei, Mr. Turtle and Mr. Helen inspecting all the surfaces. This QA inspector accepted 2 sections, i.e. P.P 77 to P.P 78 and P.P 76 to 77 after removing Dust, paint touch ups and stain marks in floor. This QA inspector rejected other sections for Grit contamination, Holidays and touch ups with Interzinc 52. The other sections - from pre weld seam to P.P 76, P.P 78 to P.P 85 and Cross beam terminal internal surface, 9BW, 9DW, offered for inspection, vide notification no. 4362. This QA inspector found ABF inspectors Mr. Sun, Mr. Wei and Mr. Turtle were doing inspection of these surfaces. It was found that, ZPMC personnels have been asked by ABF inspectors to remove dust, contaminations and stains in all the surfaces wherever found. After cleaning these contaminants, these surfaces have been accepted. DFT measured as per Paint application 2 and found within acceptable range. International protective coatings technical service representative Mr. Li Peng was found present during the course of this inspection process. (Photo of internal surfaces is attached)

Lift 9-West -Inside final acceptance inspection

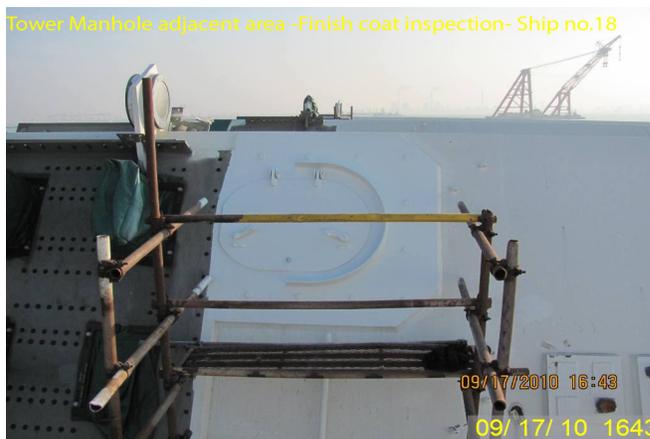
6. An inspection was requested on the Tower external man hole adjacent areas, TL2E, S, W, N -4 areas for DFT check, Residual chlorides test and MEK test vide notification no. T 1201, at Ship no. 18- Heavy Dock. This QA

inspector observed residual chloride test and MEK test have not been conducted by ZPMC personnels before mist coat. Ambient conditions have been monitored and found to be 9.3 deg. above dew point and Relative humidity found to be 57.3% which is acceptable as per contract documents for painting. The surface temperature found to be 30 deg. celcius. After finishing the Interfine 979, Finish coat, This QA inspector measured the DFT and found to be in the range of 87 to 180 which is not acceptable as per contract documents. ABF inspector Mr. Don Walton have been informed for the same in the evening. Mr. Aaron prichlik also have been informed about this by telephone. International protective coatings technical service representative Mr. Li Peng was found present during the coarse of this inspection process. (Photo attached)

Tower Manhole adjacent area -Finish coat inspection- Ship no.18

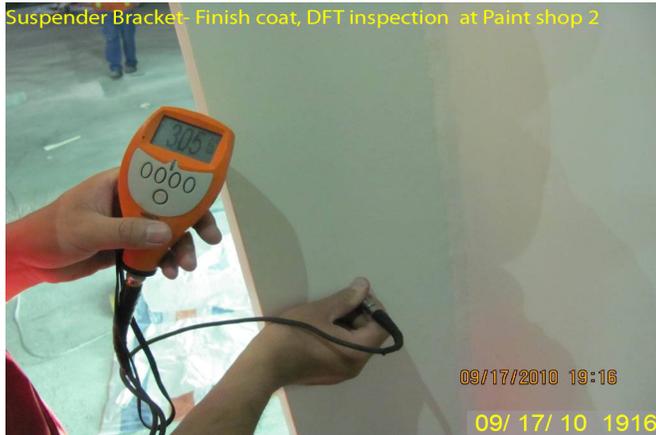
4. An inspection was requested on the Suspender Bracket -14 nos, Counter weight cover plate -14 nos and CB 11 ACCESSORIES, M201A -9 nos for DFT Check and final acceptance inspection prior to transport from the workshop, at Paint shop 2, vide inspection request no. 4354. This QA inspector observed, ABF inspector Mr. Helen and Mr. Turtle inspected these items. Mr. Aaron Prichlik from Caltrans have been informed for final acceptance of Suspender Brackets and Counter weight cover plates. It was found, Mr. Aaron prichlik accepted 5 nos of Suspender Brackets and the no. is as follows, SB72E, SB76E, SB80W, SB80E, and SB 74E. Other 9 nos, have been found rejected by Mr. Aaron prichlik for High DFT, Grit contamination, Sagging and Wrinkles. These counter weights have been found offered for inspection again after necessary rectifications in the evening. This QA inspector observed that, the marked points for Sagging, High DFT etc, have been found attended by ZPMC Personnels and the DFT found within the acceptable range. This was informed to Mr. Aaron Prichlik by phone. International protective coatings technical service representative Mr. Li Peng was found present during the coarse of this inspection process. (Photo of DFT check in suspender Bracket is attached)

Suspender Bracket- Finish coat, DFT inspection at Paint shop 2
