**DEPARTMENT OF TRANSPORTATION**

Office of Structural Materials

Contract #: 04-0120F4Cty: SF/ALA Rte: 80 PM: 13.2/13.9File #: 69.15**SOURCE INSPECTION REPORT****Resident Engineer:** Siegenthaler, Peter**Address:** 333 Burma Road**City:** Oakland, CA 94607**Report No:** SIR-002710**Date Inspected:** 15-Oct-2010**Project Name:** SAS Superstructure**OSM Arrival Time:** 700**Prime Contractor:** American Bridge/Fluor Enterprises, a JV**OSM Departure Time:** 1900**Contractor:** Zhenhua Port Machinery Company, Ltd (ZPMC), Changxing Island **Location:** Shanghai, China**Quality Control Contact:** Mr. Don Walton**Quality Control Present:** Yes No**Material transfer:** Yes No N/A**Sampled Items:** Yes No N/A**Stock Transfer:** Yes No N/A**OK to Cut:** Yes No N/A**Rebar Test Witness:** Yes No N/A**Delayed/Cancelled:** Yes No N/A**Other:** Coating Inspection**Bridge No:** 34-0006**Component:** See Below**Bid Item:** 77, 78, 79**Lot No:** B # 204**Summary of Items Observed:**

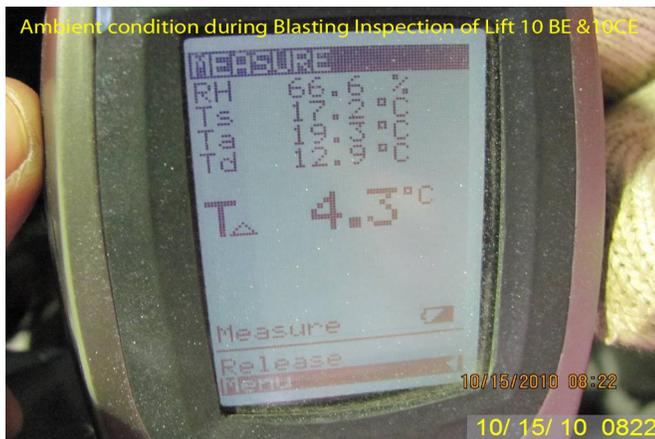
An inspection was requested on the OBG Segment, Lift 10 East, connection weld seam entire internal surface between 10BE & 10CE, vide inspection request no. 4596 at OBG assembly yard.. This QA inspector observed, ABF Inspectors Mr. Hong, and Mr. Vince inspecting these surfaces for surface profile as per SSPC SP 10. This QA inspector observed, surface profile measured by ZPMC QC inspectors found to be in the range of 72 to 84 microns which is acceptable as per contract Documents. Ambient conditions found measured by ZPMC QC Inspectors 4.3 deg. celcius above due point and the relative humidity found to be 66.6 % which is acceptable as per contract documents. This profile found accepted for Interzinc 22 application after minor touch ups. International protective coatings technical service representative Mr. Yang was found present during the coarse of this inspection process. (Photo of ambient conditions measured is attached)

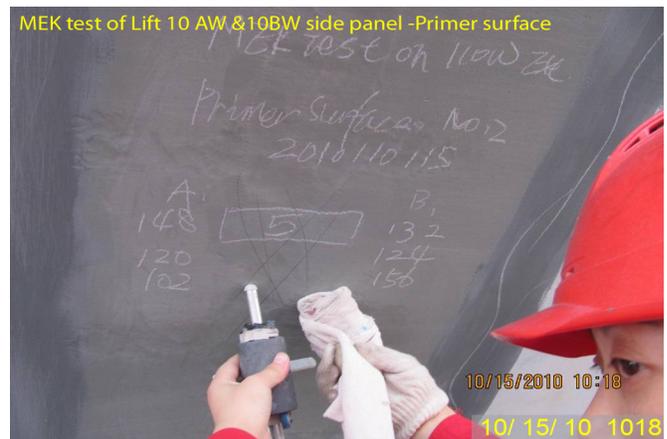
An inspection was requested on the OBG connection weld seam External surface between 10AW, 10BW and Between 10BW, 10CW and Entire bottom plate except the Cross beam bottom plate of Lift 10 -L10W for MEK test, DFT Check and Salt test for the application of Mist and Finish coat , vide request no. 4597 at OBG assembly yard. This QA inspector observed, ABF inspector Mr. Stone, Mr. Wang and Mr. Vince performing the required inspections. The MEK test found to be carried out in 2 places and the result observed as Grade 5 . The Result of

Residual chloride test carried out in 2 places found to be 9.8 us/cm and 10us/cm respectively. The result of Salt test and MEK tests found to be acceptable as per contract documents. International protective coatings technical service representative Mr. Yang. was found present during the coarse of this inspection process. (Photo of MEK Test is attached)
