DEPARTMENT OF TRANSPORTATION

Contract #: 04-0120F4Cty: SF/ALA Rte: 80 PM: 13.2/13.9File #: 69.15**SOURCE INSPECTION REPORT****Resident Engineer:** Siegenthaler, Peter**Address:** 333 Burma Road**City:** Oakland, CA 94607**Report No:** SIR-002880**Date Inspected:** 07-Jan-2011**Project Name:** SAS Superstructure**OSM Arrival Time:** 1500**Prime Contractor:** American Bridge/Fluor Enterprises, a JV**OSM Departure Time:** 300**Contractor:** Zhenhua Port Machinery Company, Ltd (ZPMC), Changxing Island **Location:** Shanghai, China**Quality Control Contact:** Mr. Don Walton**Quality Control Present:** Yes No**Material transfer:** Yes No N/A**Sampled Items:** Yes No N/A**Stock Transfer:** Yes No N/A**OK to Cut:** Yes No N/A**Rebar Test Witness:** Yes No N/A**Delayed/Cancelled:** Yes No N/A**Other:** Coating Inspection**Bridge No:** 34-0006**Component:** See Below**Bid Item:** 77, 78, 79**Lot No:** B #204**Summary of Items Observed:**

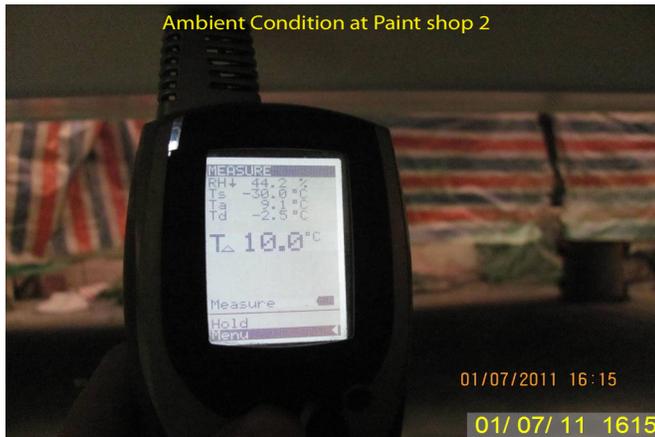
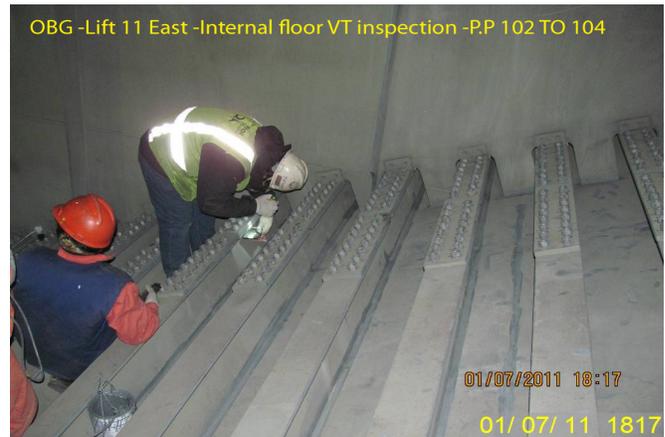
An inspection was requested on the OBG Lift 11 East, Internal entire floor from Panel point P.P 102 to P.P 104 for DFT check after Interzinc 22 application and final VT acceptance vide inspection request no. 5647 at OBG assembly yard. This QA inspector observed, ABF Inspectors Mr. Shi Stone, and Mr. Wei found inspecting these surfaces for DFT. This was found not accepted by ABF Inspectors for Overspray, Holidays, sagging and poor surface preparations. Ambient conditions found measured by ZPMC QC Inspectors 10.6 deg. celcius above due point and the relative humidity found to be 41.3 % which is acceptable as per contract documents. International protective coatings technical service representative Mr. Li Peng was found present during the course of this inspection process.

An inspection was requested on the OBG Cross Beam support areas, CB 15 & CB16 for DFT check after Interzinc 22 application and MEK test vide inspection request no. 5646 at OBG assembly yard. This QA inspector observed, ABF Inspectors Mr. Shi Stone, and Mr. Wei found inspecting these surfaces for DFT and MEK test. This was found not accepted by ABF Inspectors for the failure of MEK test conducted on CB 15 Bottom Support areas. Ambient conditions found measured by ZPMC QC Inspectors 10.5 deg. celcius above due point and the relative humidity found to be 42.6 % which is acceptable as per contract documents. International protective

An inspection was requested on the OBG Crash Barrier Internal surfaces -28 nos for DFT check after Interzinc 22 application vide inspection request no. 5648 at Paint shop 2. This QA inspector observed, ABF Inspectors Mr. Shi Stone, found inspecting these surfaces for DFT. This was found not accepted by ABF Inspectors for Low DFT, Overspray, Holidays, sagging and Wet Interzinc 52 in the edges. Ambient conditions found measured by ZPMC QC Inspectors 10.0 deg. celcius above dew point and the relative humidity found to be 44.2 % which is acceptable as per contract documents. International protective coatings technical service representative Mr. Andy was found present during the course of this inspection process.
