DEPARTMENT OF TRANSPORTATION

Quality Assurance and Source Inspection

Contract #: 04-0120F4Cty: SF/ALA Rte: 80 PM: 13.2/13.9File #: 69.15**SOURCE INSPECTION REPORT****Resident Engineer:** Siegenthaler, Peter**Address:** 333 Burma Road**City:** Oakland, CA 94607**Report No:** SIR-002883**Date Inspected:** 09-Jan-2011**Project Name:** SAS Superstructure**OSM Arrival Time:** 1500**Prime Contractor:** American Bridge/Fluor Enterprises, a JV**OSM Departure Time:** 300**Contractor:** Zhenhua Port Machinery Company, Ltd (ZPMC), Changxing Island **Location:** Shanghai, China**Quality Control Contact:** Mr. Don Walton**Quality Control Present:** Yes No**Material transfer:** Yes No N/A**Sampled Items:** Yes No N/A**Stock Transfer:** Yes No N/A**OK to Cut:** Yes No N/A**Rebar Test Witness:** Yes No N/A**Delayed/Cancelled:** Yes No N/A**Other:** Coating Inspection**Bridge No:** 34-0006**Component:** See Below**Bid Item:** 77, 78, 79**Lot No:** B #204**Summary of Items Observed:**

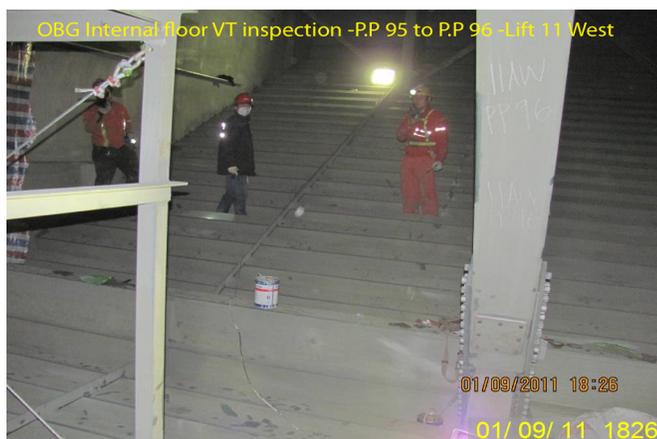
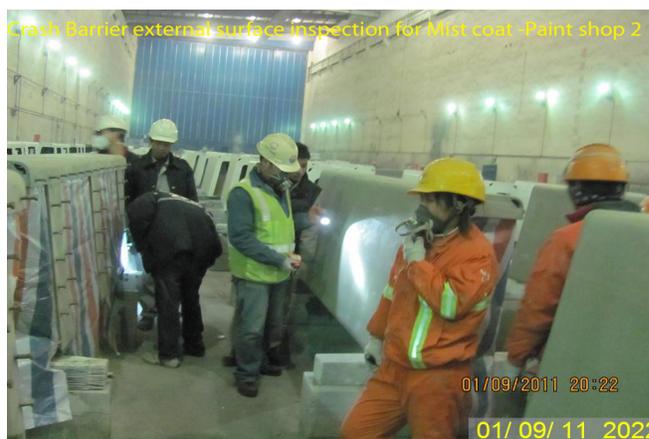
Unless otherwise noted, all work observed on this date appeared to generally comply with applicable contract documents.
