**DEPARTMENT OF TRANSPORTATION**

Contract #: 04-0120F4Cty: SF/ALA Rte: 80 PM: 13.2/13.9File #: 69.15**SOURCE INSPECTION REPORT****Resident Engineer:** Siegenthaler, Peter**Address:** 333 Burma Road**City:** Oakland, CA 94607**Report No:** SIR-002885**Date Inspected:** 11-Jan-2011**Project Name:** SAS Superstructure**OSM Arrival Time:** 1500**Prime Contractor:** American Bridge/Fluor Enterprises, a JV**OSM Departure Time:** 300**Contractor:** Zhenhua Port Machinery Company, Ltd (ZPMC), Changxing Island **Location:** Shanghai, China**Quality Control Contact:** Don Walton**Quality Control Present:** Yes No**Material transfer:** Yes No N/A**Sampled Items:** Yes No N/A**Stock Transfer:** Yes No N/A**OK to Cut:** Yes No N/A**Rebar Test Witness:** Yes No N/A**Delayed/Cancelled:** Yes No N/A**Other:** Coating Inspection**Bridge No:** 34-0006**Component:** See Below**Bid Item:** 77, 78, 79**Lot No:** B #204**Summary of Items Observed:**

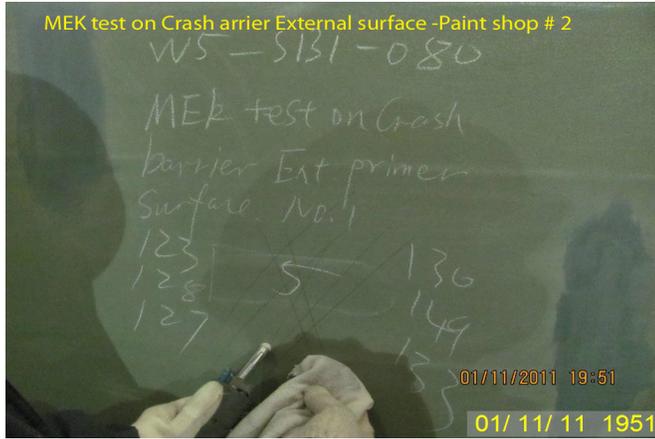
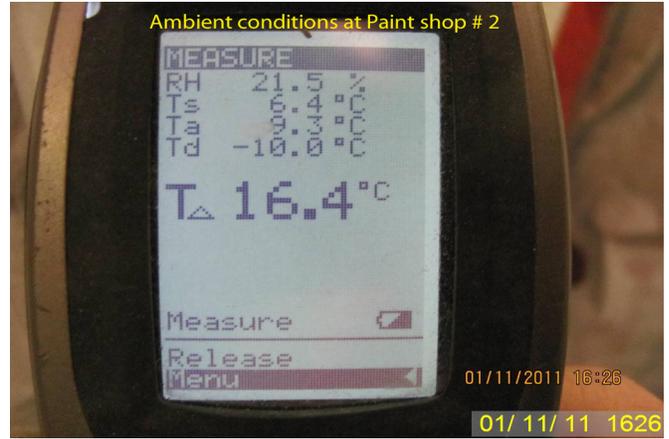
Unless otherwise noted, all work observed on this date appeared to generally comply with applicable contract documents.
