**DEPARTMENT OF TRANSPORTATION**

Contract #: 04-0120F4Cty: SF/ALA Rte: 80 PM: 13.2/13.9File #: 69.15**SOURCE INSPECTION REPORT****Resident Engineer:** Siegenthaler, Peter**Address:** 333 Burma Road**City:** Oakland, CA 94607**Report No:** SIR-002887**Date Inspected:** 14-Jan-2011**Project Name:** SAS Superstructure**OSM Arrival Time:** 1500**Prime Contractor:** American Bridge/Fluor Enterprises, a JV**OSM Departure Time:** 300**Contractor:** Zhenhua Port Machinery Company, Ltd (ZPMC), Changxing Island **Location:** Shanghai, China**Quality Control Contact:** Don Walton**Quality Control Present:** Yes No**Material transfer:** Yes No N/A**Sampled Items:** Yes No N/A**Stock Transfer:** Yes No N/A**OK to Cut:** Yes No N/A**Rebar Test Witness:** Yes No N/A**Delayed/Cancelled:** Yes No N/A**Other:** Coating Inspection**Bridge No:** 34-0006**Component:** See Below**Bid Item:** 77, 78, 79**Lot No:** B # 204**Summary of Items Observed:**

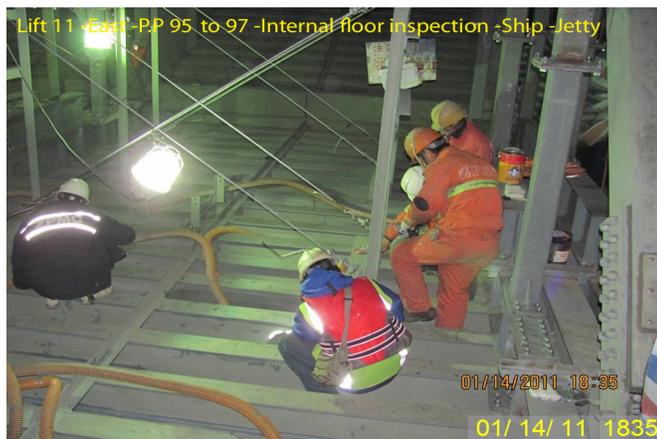
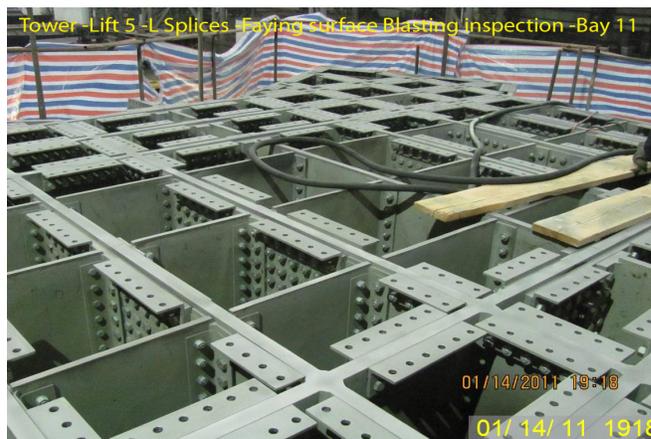
An inspection was requested on the OBG Lift 11 East, Internal entire floor from Panel point P.P 95 to P.P 97 -2 sections for DFT check after Interzinc 22 application and final VT acceptance vide inspection request no. 5770 at Ship in Heavy Dock Jetty. This QA inspector observed, ABF Inspectors Mr. Sun and Mr. Wei found inspecting these surfaces for DFT . Panel point 95 to 96 found accepted by ABF Inspectors after minor touch ups in corners. P.P 96 to 97 was found not accepted by ABF Inspectors for Holidays, sagging and Overspray in some of the areas.
