**DEPARTMENT OF TRANSPORTATION**

Contract #: 04-0120F4Cty: SF/ALA Rte: 80 PM: 13.2/13.9File #: 69.15**SOURCE INSPECTION REPORT****Resident Engineer:** Siegenthaler, Peter**Address:** 333 Burma Road**City:** Oakland, CA 94607**Report No:** SIR-002893**Date Inspected:** 20-Jan-2011**Project Name:** SAS Superstructure**OSM Arrival Time:** 1500**Prime Contractor:** American Bridge/Fluor Enterprises, a JV**OSM Departure Time:** 300**Contractor:** Zhenhua Port Machinery Company, Ltd (ZPMC), Changxing Island **Location:** Shanghai, China**Quality Control Contact:** Mr. Don Walton**Quality Control Present:** Yes No**Material transfer:** Yes No N/A**Sampled Items:** Yes No N/A**Stock Transfer:** Yes No N/A**OK to Cut:** Yes No N/A**Rebar Test Witness:** Yes No N/A**Delayed/Cancelled:** Yes No N/A**Other:** Coating Inspection**Bridge No:** 34-0006**Component:** See Below**Bid Item:** 77, 78, 79**Lot No:** B #204**Summary of Items Observed:**

# SOURCE INSPECTION REPORT

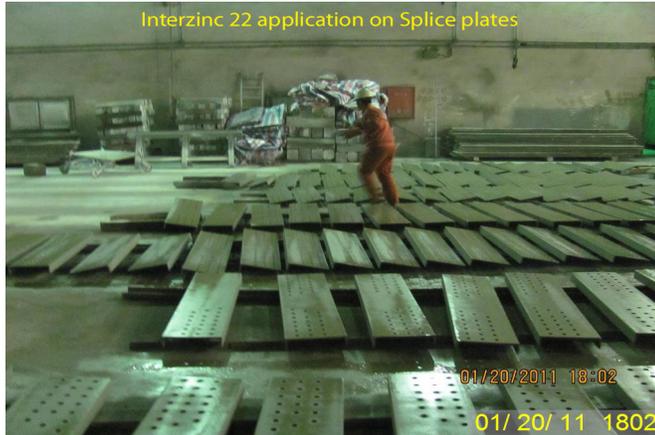
Unless otherwise noted, all work observed on this date appeared to generally comply with applicable contract documents.
