DEPARTMENT OF TRANSPORTATION

Contract #: 04-0120F4Cty: SF/ALA Rte: 80 PM: 13.2/13.9File #: 69.28**WELDING INSPECTION REPORT****Resident Engineer:** Pursell, Gary**Address:** 333 Burma Road**City:** Oakland, CA 94607**Report No:** WIR-000008**Date Inspected:** 09-Nov-2006**Project Name:** SAS Superstructure**OSM Arrival Time:** 800**Prime Contractor:** American Bridge/Fluor Enterprises, a JV**OSM Departure Time:** 1730**Contractor:** Zhenhua Port Machinery Company, Ltd (ZPMC), Changxing Island **Location:** Shanghai, China**CWI Name:** Liu Liu and Huang Wei**CWI Present:** Yes No**Inspected CWI report:** Yes No N/A**Rod Oven in Use:** Yes No N/A**Electrode to specification:** Yes No N/A**Weld Procedures Followed:** Yes No N/A**Qualified Welders:** Yes No N/A**Verified Joint Fit-up:** Yes No N/A**Approved Drawings:** Yes No N/A**Approved WPS:** Yes No N/A**Delayed / Cancelled:** Yes No N/A**Bridge No:** 34-0006**Component:** N/A**Summary of Items Observed:**

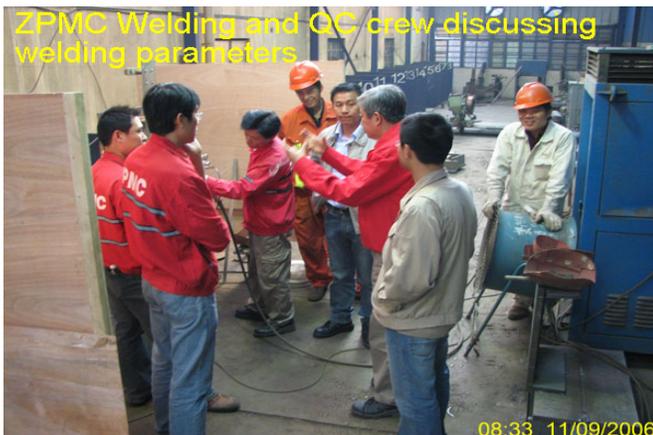
This Quality Assurance Inspector observed the Quality Control Inspector, Mr. Liu Liu and Mr. Huang Wei witnessing the running of a flux-cored arc welding procedure qualification test HP2006106 in the shop at ZPMC. The test was being run to Paragraph 5.12 for minimum heat input in the vertical welding position (3G). The welders were Lei Li Chao and Zhang Xing Jin who were using Hyundai, Supercored 71, and 1.4 millimeter diameter wire with welding procedure specification PWPS-B-T-2233FB. Welding of this procedure qualification was not completed by the end of the shift so welding will be continued tomorrow on Friday November 10, 2006.
