DEPARTMENT OF TRANSPORTATION

Contract #: 04-0120F4Cty: SF/ALA Rte: 80 PM: 13.2/13.9File #: 69.28**WELDING INSPECTION REPORT****Resident Engineer:** Pursell, Gary**Address:** 333 Burma Road**City:** Oakland, CA 94607**Report No:** WIR-000277**Date Inspected:** 09-Jul-2007**Project Name:** SAS Superstructure**OSM Arrival Time:** 800**Prime Contractor:** American Bridge/Fluor Enterprises, a JV**OSM Departure Time:** 1730**Contractor:** Zhenhua Port Machinery Company, Ltd (ZPMC), Changxing Island **Location:** Shanghai, China

WELDING INSPECTION REPORT

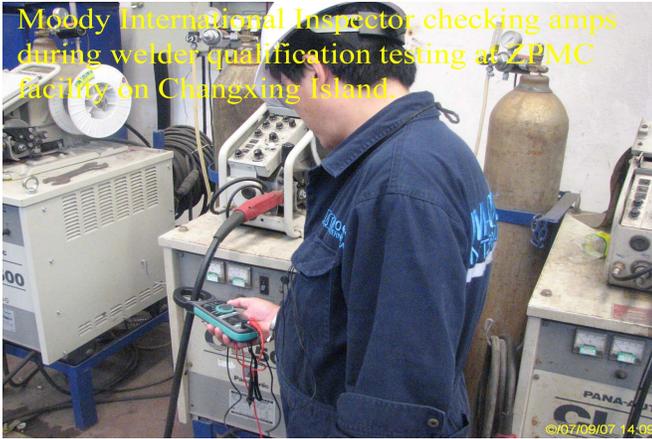
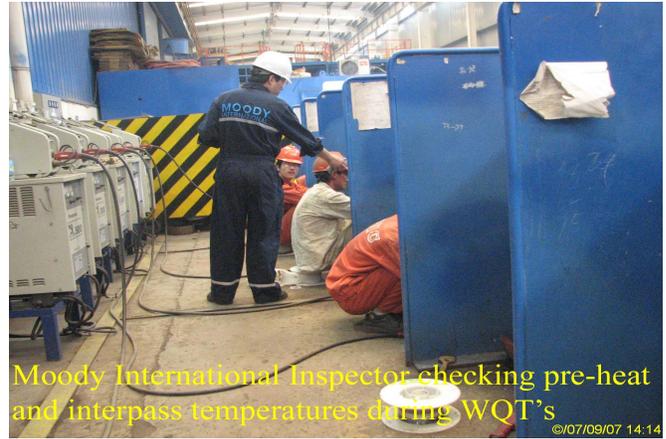
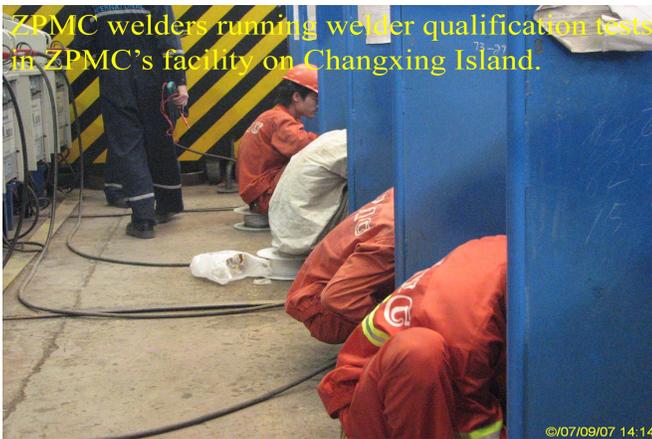
Caltrans Quality Assurance (QA) Inspector Bruce J. Berger observed welder qualification testing (WQT) by Moody International Inspectors Feng Lin Yao, Tang Li Pang, Zhou Daqing and He Jia Min at ZPMC today. There was one ZPMC Certified Welding Inspector, Xu Xian Ping with four assistants and one American Bridge/Fluor employee Mr. Danny McDonald. There were a total of 40 welders which were to be tested today in the shield metal arc (SMAW), submerged arc (SAW) and the flux cored arc (FCAW) welding process. Both the Moody International and ZPMC inspectors were observed checking the welding parameters for the welders being tested. A random inspection was made of the various volt/amp gauges and temperature gauges for calibration of which all were found to be in a current state of calibration.

Radiographic Film Review: This Quality Assurance Inspector reviewed film for procedure qualification test HP2007370 which was a 26 millimeter thick complete butt joint penetration weld. While there was some porosity observed in the film the weld appeared to be in compliance with the code and specifications.
