**DEPARTMENT OF TRANSPORTATION**

Contract #: 04-0120F4Cty: SF/ALA Rte: 80 PM: 13.2/13.9File #: 69.28**WELDING INSPECTION REPORT****Resident Engineer:** Pursell, Gary**Address:** 333 Burma Road**City:** Oakland, CA 94607**Report No:** WIR-000379**Date Inspected:** 25-Aug-2007**Project Name:** SAS Superstructure**OSM Arrival Time:** 1400**Prime Contractor:** American Bridge/Fluor Enterprises, a JV**OSM Departure Time:** 2200**Contractor:** Zhenhua Port Machinery Company, Ltd (ZPMC), Changxing Island **Location:** Shanghai, China**CWI Name:** Xu Le Feng**CWI Present:** Yes No**Inspected CWI report:** Yes No N/A**Rod Oven in Use:** Yes No N/A**Electrode to specification:** Yes No N/A**Weld Procedures Followed:** Yes No N/A**Qualified Welders:** Yes No N/A**Verified Joint Fit-up:** Yes No N/A**Approved Drawings:** Yes No N/A**Approved WPS:** Yes No N/A**Delayed / Cancelled:** Yes No N/A**Bridge No:** 34-0006**Component:** Mock-Up 77.00**Summary of Items Observed:**

Caltrans Quality Assurance (QA) Inspector, Mike Hasler was present to observe the fitup and welding of the Caltrans Mock-up #77.00, for the San Francisco Oakland Bay Self Anchored Suspension Bridge, at Zhenhua Port Machiner

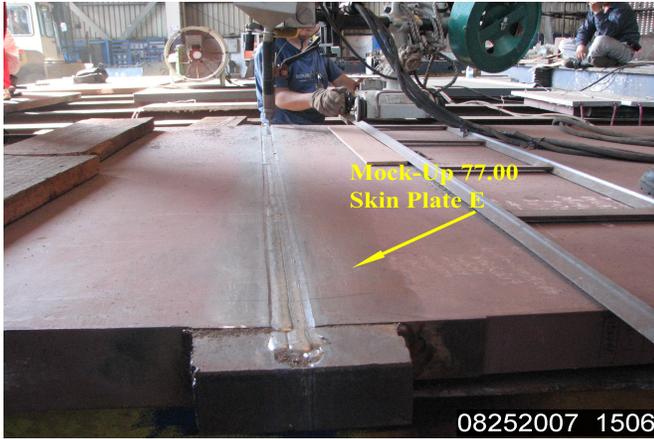
Caltrans QA Inspector observed submerged arc welding (SAW) in progress at skin plate E, piecemark mp14 to MA5, outside, side. The in process subassembly fabrication, appears to be at step 6.1 in regards to the mock-up fabrication procedure flow plan. The weld joint is identified as a double-vee butt joint with a partial joint penetration weld. The welder operator is identified as Mr. Xue Yan. The approved welder is observed welding the partial joint penetration (PJP), fill and cover pass welds, in the flat position. The welder is using welding procedure specification (WPS), WPS-B-T-2321-B-P3-S, Revision 0. Caltrans QA Inspector measured current welding operating parameters at approximately 680 amps, 34.0 volts, 675 millimeters per minute (mm/min) travel speed. Preheat and interpass temperatures were verified during welding activities. Preheat temperature prior to the start of welding, measured more than 110 Celsius (230 degree Fahrenheit) but less than 232 Celsius (450 degrees Fahrenheit) during maximum interpass temperature verification. Caltrans QA observed ZPMC Quality Control (QC) inspector, Mr. Xu Le Feng and Bureau Vereitas QC inspector, Mr. Hou Jing Yao monitoring welding in progress. Following digital picture illustrates welding in progress.

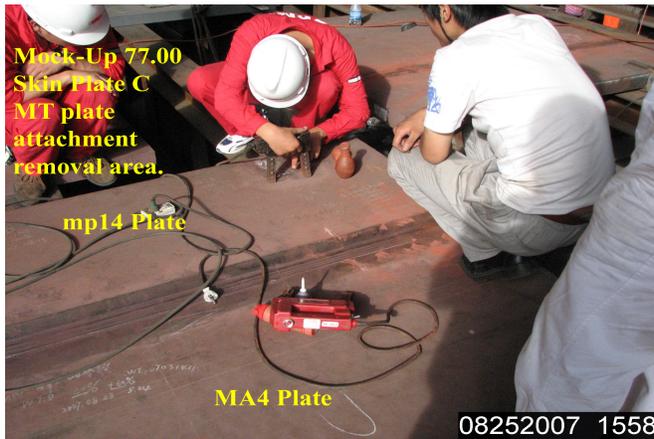
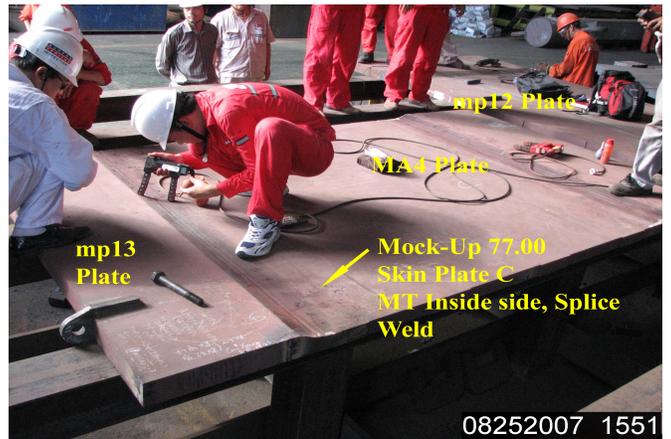
Item	Description	WBS	Dwg No.	Status
1	ZPMC MT Inspection	NA	NA	Testing In Progress

Caltrans QA Inspector observed ZPMC QC nondestructive technician, Mr. Cai Xin Xin perform magnetic particle testing (MT) and Visual Testing (VT). The testing was performed at the plate splice welds and plate attachment removal locations. The subassemblies tested and locations are identified as, skin plate B, inside side, splice weld, two attachment removal locations, and outside side, splice weld; skin plate C, welds 1 and 2, inside side, splice weld, two attachment removal locations, and outside side, splice welds 1 and 2; skin plate D, inside side, two attachment removal locations and, outside side, four attachment removal locations. The testing appeared to be in general conformance with AWS D1.5 2002 requirements. At the conclusion of each inspection, ZPMC QC inspector, Mr. Xu Le Feng reported that welds and attachment locations were found acceptable. Following digital pictures illustrates MT in progress.

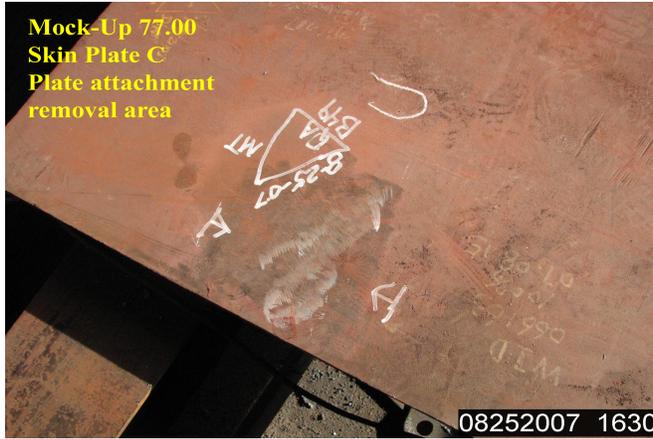
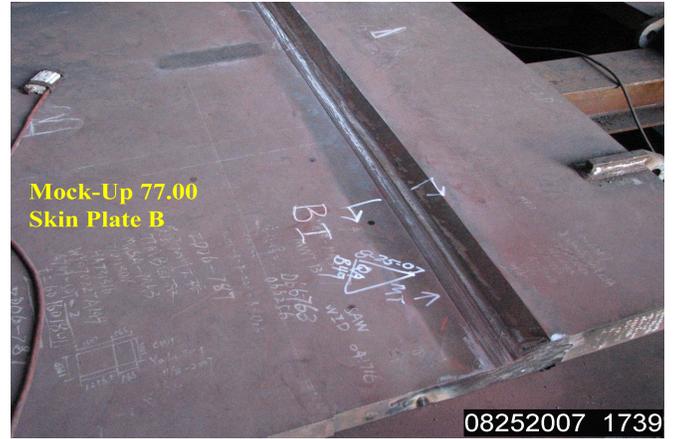
2	Skin Plate MT testing	NA	NA	Caltrans QA MT Testing
---	-----------------------	----	----	------------------------

The Caltrans QA Inspector performed visual test (VT) and MT examinations of the plate splice welds and plate attachment removal locations at skin plate B, C and D. Caltrans QA Inspector observed that the welds and plate attachment removal locations appeared to be in general conformance with AWS D1.5 2002 requirements. See MT report TL6028, generated on this date for further information.
