**DEPARTMENT OF TRANSPORTATION**

Contract #: 04-0120F4Cty: SF/ALA Rte: 80 PM: 13.2/13.9File #: 69.28**WELDING INSPECTION REPORT****Resident Engineer:** Pursell, Gary**Address:** 333 Burma Road**City:** Oakland, CA 94607**Report No:** WIR-000396**Date Inspected:** 27-Aug-2007**Project Name:** SAS Superstructure**OSM Arrival Time:** 1400**Prime Contractor:** American Bridge/Fluor Enterprises, a JV**OSM Departure Time:** 2230**Contractor:** Zhenhua Port Machinery Company, Ltd (ZPMC), Changxing Island **Location:** Shanghai, China**CWI Name:** Xu Le Feng**CWI Present:** Yes No**Inspected CWI report:** Yes No N/A**Rod Oven in Use:** Yes No N/A**Electrode to specification:** Yes No N/A**Weld Procedures Followed:** Yes No N/A**Qualified Welders:** Yes No N/A**Verified Joint Fit-up:** Yes No N/A**Approved Drawings:** Yes No N/A**Approved WPS:** Yes No N/A**Delayed / Cancelled:** Yes No N/A**Bridge No:** 34-0006**Component:** Caltrans Mock-Up 77.00**Summary of Items Observed:**

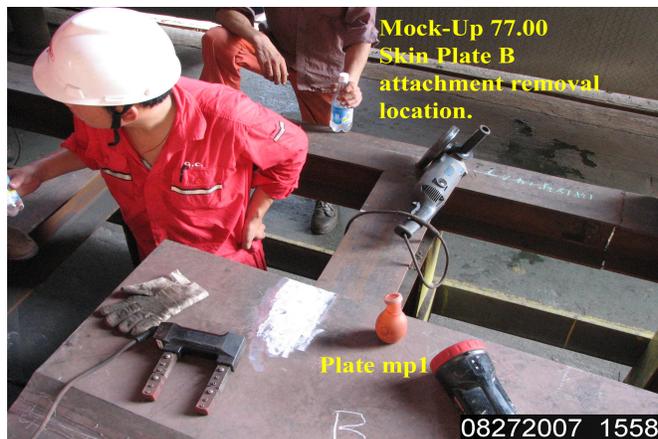
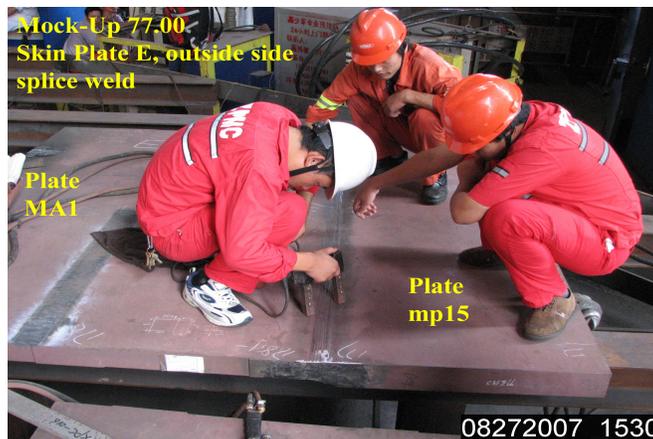
2	Skin Plate E and B	NA	NA	QA MT
---	--------------------	----	----	-------

Caltrans QA Inspector observed ZPMC QC nondestructive technician, Mr. Cai Xin Xin perform magnetic particle testing (MT) and Visual Testing (VT). The testing was performed at the plate splice welds and plate attachment removal locations. The subassemblies tested and locations are identified as, skin plate E, inside side, splice weld, two attachment removal locations, and outside side, splice weld; skin plate B, four attachment removal locations, inside side. The testing appeared to be in general conformance with AWS D1.5 2002 requirements. At the conclusion of each inspection, ZPMC QC inspector, Mr. Xu Le Feng reported that welds and attachment locations were found acceptable. Following digital pictures illustrates MT in progress.

The Caltrans QA Inspector performed visual test (VT) and MT examinations of the plate splice welds and plate attachment removal locations at skin plate E and B. Caltrans QA Inspector observed that the welds and plate attachment removal locations appeared to be in general conformance with AWS D1.5 2002 requirements. See MT report TL6028, generated on this date for further information.
