Contract #: 04-0120F4
 Cty: SF/ALA Rte: 80 PM: 13.2/13.9
 File #: 69.28

WELDING INSPECTION REPORT

Report No: WIR-000439
Date Inspected: 02-Sep-2007

Project Name: SAS Superstructure **OSM Arrival Time:** 2330
Prime Contractor: American Bridge/Fluor Enterprises, a JV **OSM Departure Time:** 800
Contractor: Zhenhua Port Machinery Company, Ltd (ZPMC), Changxing Island **Location:** Shanghai, China

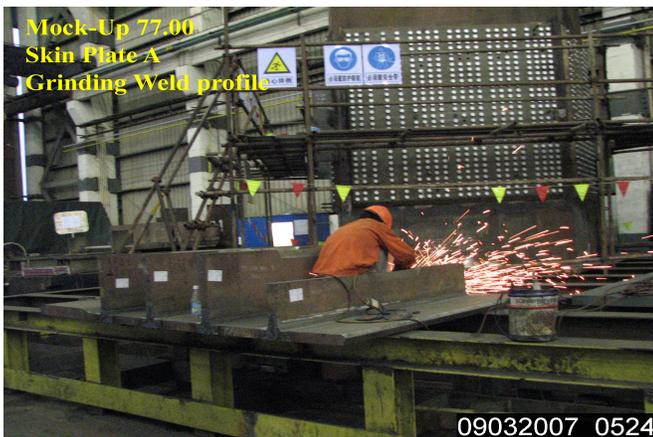
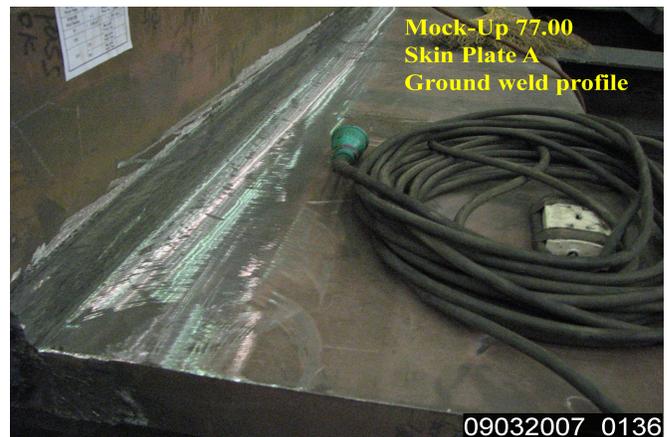
Mock-Up 77.00, skin plate A assembly: Caltrans QA Inspector observed ZPMC shop personnel perform weld profile grinding on the complete joint penetration welds, connecting stiffener plates to the skin plate. The cover pass surfaces of the welds are being ground smooth to blend smoothly into the plate surfaces with the transition areas being free from weld edge undercut. Following digital picture illustrates grinding in progress and weld profile, after grinding.

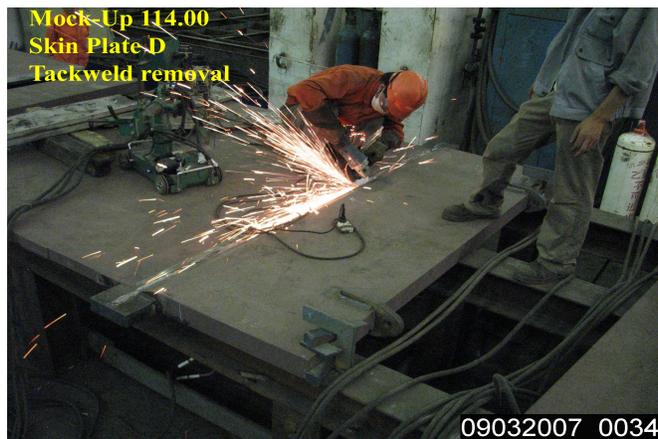
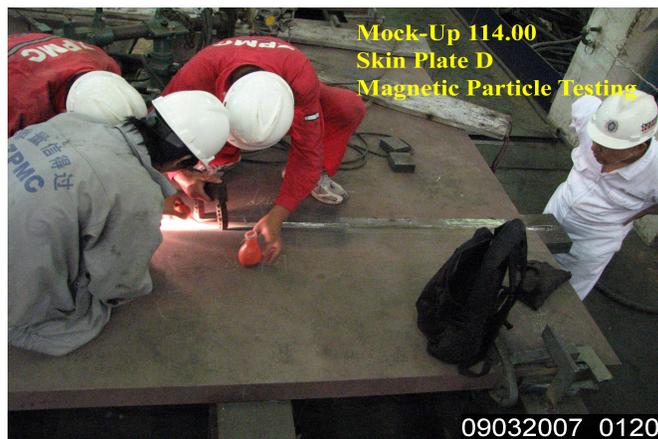
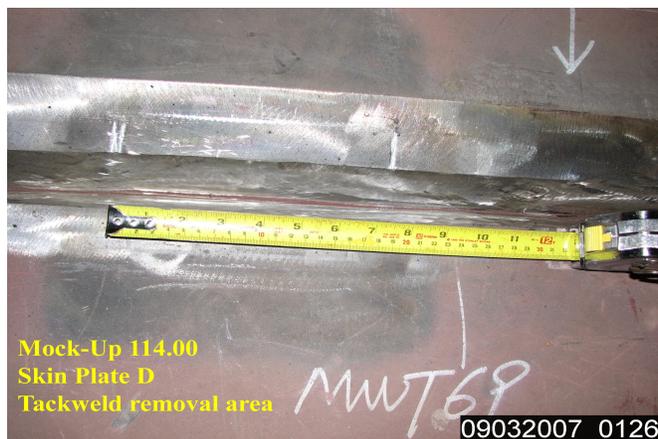
Mock-Up 114.00, skin plate D assembly: Caltrans QA Inspector observed ZPMC perform tackweld removal at splice plate weld, weld number MUSC-MA 110-1 bottom. The assembly was observed to have a crack tackweld and appeared to be cracked the full length of the weld, and measured 178 mm in length. ZPMC elected to remove the tackweld by grinding. The weld excavation area and the remaining tackwelds were then magnetic particle tested by ZPMC QC testing technician, Mr. Cai Xin Xin. At the conclusion of the testing Mr. Cai Xin Xin stated that no relevant indications were observed and is accepted by ZPMC QC. ZPMC QA inspector, Mr. Zhang Jia di stated that this assembly would be turned over to the day shift for welding. Following digital pictures illustrate removal of the cracked tackweld and ZPMC magnetic particle testing.
