**DEPARTMENT OF TRANSPORTATION**

Contract #: 04-0120F4Cty: SF/ALA Rte: 80 PM: 13.2/13.9File #: 69.28**WELDING INSPECTION REPORT****Resident Engineer:** Pursell, Gary**Address:** 333 Burma Road**City:** Oakland, CA 94607**Report No:** WIR-000460**Date Inspected:** 13-Sep-2007**Project Name:** SAS Superstructure**OSM Arrival Time:** 630**Prime Contractor:** American Bridge/Fluor Enterprises, a JV**OSM Departure Time:** 1530**Contractor:** Zhenhua Port Machinery Company, Ltd (ZPMC), Changxing Island **Location:** Shanghai, China**CWI Name:** Lu Jian Ping**CWI Present:** Yes No**Inspected CWI report:** Yes No N/A**Rod Oven in Use:** Yes No N/A**Electrode to specification:** Yes No N/A**Weld Procedures Followed:** Yes No N/A**Qualified Welders:** Yes No N/A**Verified Joint Fit-up:** Yes No N/A**Approved Drawings:** Yes No N/A**Approved WPS:** Yes No N/A**Delayed / Cancelled:** Yes No N/A**Bridge No:** 34-0006**Component:** Mock Up, Welder Performance Quals**Summary of Items Observed:**

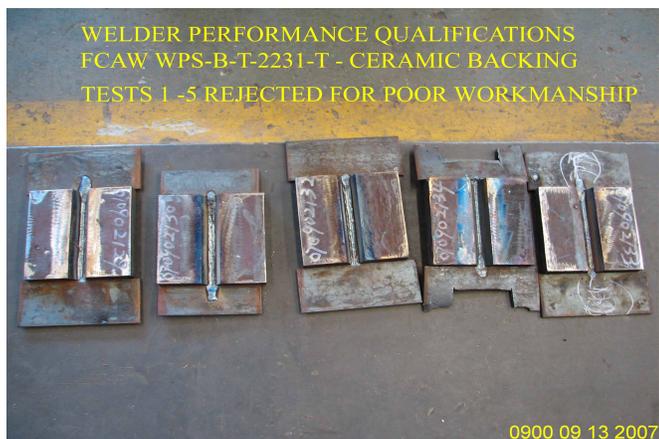
Caltrans Quality Assurance (QA) Inspector Charlie Franco was present at the time requested to randomly observe welding being performed for welder qualification. The QA Inspector observed the flux cored arc welding (FCAW) process being used in the 1G position with ceramic backing strips attached. The QA Inspector observed several welders placing root passes in their test pieces utilizing the FCAW process with ZPMC approved weld procedure specification WPS-B-T-2231-T. The QA Inspector observed QA/QC Engineer Jiang Weifeng of 3rd party inspection agency Moody International, inspecting the root passes of the test pieces. Mr. Jiang rejected 5 out of the first 6 test samples for cracks and other poor workmanship issues in the face and root sides of the root passes of the test weldments. The QA Inspector was called to go observe work being performed for the Mock Up, and did not observe any further welder performance qualifications. The attached photograph provides additional detail.

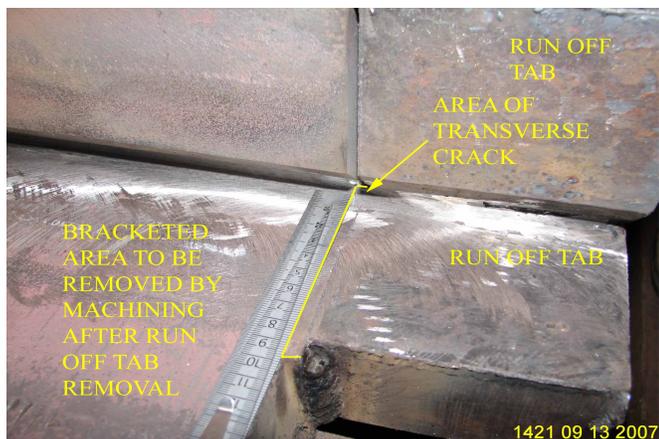
As the QA Inspector was awaiting transportation at the end of the shift, he was informed by ZPMC QA Representative Li Xin Yang that a crack had been found at the very beginning of Magnetic Particle Testing of WJ's 5 and 6 on sub assembly MA112. Mr. Li informed the QA Inspector that the crack was in the run off tab and would be removed once the weld was completed. Mr. Li asked the QA Inspector if it would be alright to continue the MT inspection and if no other defects were found, continue with the welding. The QA Inspector walked over to sub assembly MA112 and looked at the area of concern. The QA Inspector observed a transverse crack beginning at the junction of the run off tab attached to skin plate C, progressing toward the longitudinal stiffener and then tailing into the skin plate. The area on the skin plate that the crack entered, was a small area that extended past the edge of skin plate C and was to be removed by machining after welding of the joint was completed. The QA Inspector informed Mr. Li that although the crack was now in an area to be removed later, it would not necessarily stay in that area. The QA Inspector informed Mr. Li that the crack could propagate into the skin plate if it was to remain as is. Mr. Li informed the QA Inspector that the crack would be removed and the area rewelded prior to continuing with the MT inspection. The following photograph provides additional detail of the location only.
