**DEPARTMENT OF TRANSPORTATION**

Contract #: 04-0120F4Cty: SF/ALA Rte: 80 PM: 13.2/13.9File #: 69.28**WELDING INSPECTION REPORT****Resident Engineer:** Pursell, Gary**Address:** 333 Burma Road**City:** Oakland, CA 94607**Report No:** WIR-000481**Date Inspected:** 12-Sep-2007**Project Name:** SAS Superstructure**OSM Arrival Time:** 1400**Prime Contractor:** American Bridge/Fluor Enterprises, a JV**OSM Departure Time:** 2300**Contractor:** Zhenhua Port Machinery Company, Ltd (ZPMC), Changxing Island **Location:** Shanghai, China

# WELDING INSPECTION REPORT

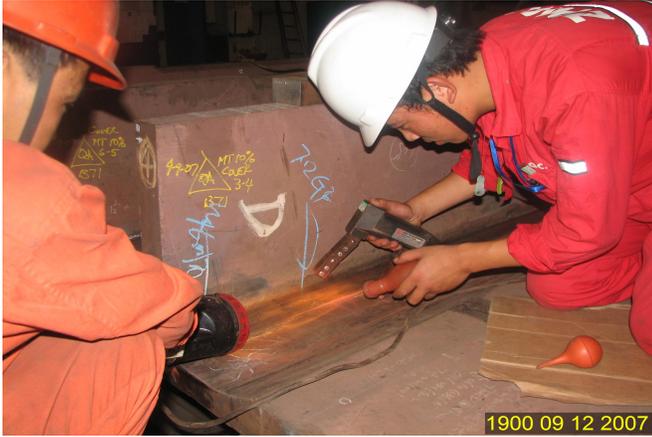
Item-1 77 Diaphragm cover pass, weld 73, on plate SA 95-1 to SA 95-2. The CWI/QC as Ye Yong Jun. Caltrans QA Inspector did witness Cai Xin Xin with ZPMC performing a dry powder Magnetic Particle (MT) test of the cover pass, weld 73. The MT yoke used was a Parker Contour Probe, model B310-S, SN 4804 with a calibration due date of May 27, 2008. The testing was conducted on the inside face of the diaphragm plates SA 95-1 to SA 95-2 and was rejected for what appeared to be two transverse grinding marks that the tech had ground prior to the QA's MT test. The grinding area had a shallow dished out spot approximately 4mm in length and 1.5mm in depth. The Caltrans QA Inspector performed an MT test on approximately 25% of the weld on plate SA 95-1 and SA 95-2 and noted no other discrepancies other than the dished out grinding area in the heat affected zone. Further grinding as to be performed on the dished out area to eliminate the two transverse grind marks located on plate SA 95-1 adjacent to weld 73.
